# Overview of the current status and plans for the 2027ab run

Takaaki Yamaguchi  
(on behalf of SuperKEKB accelerator team)

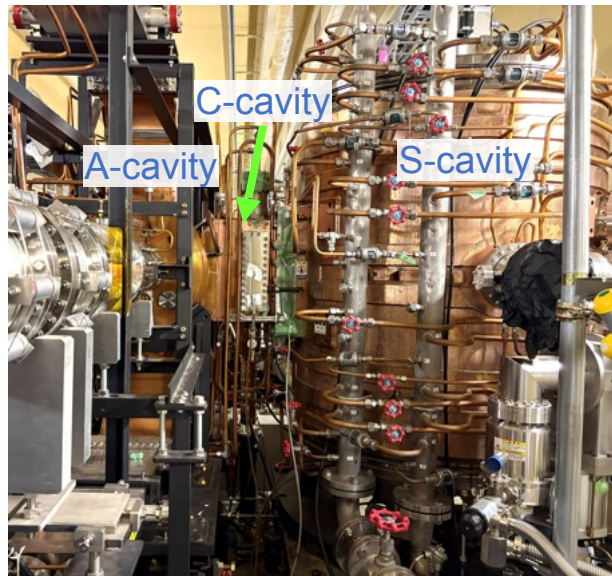
- D05A cavity:**
- The source of pressure rise was a vacuum leak at the joint between the C- and S-cavity.
  - By obscure failure of a flap flow meter, cooling water flow was insufficient at the middle part of the storage cavity.  
→ Large thermal expansion led to vacuum leak at the joint.
- D05F cavity:**
- On a regular maintenance day, cooling water leak was found on the top of the storage cavity.
  - After partial removal work of cooling water, cavity aging was conducted as usual. → Abnormal vacuum-pressure rise occurred.
  - By leak tests and high-power tests in this summer shutdown, vacuum-pressure rise could not be reproduced.
  - A possible cause of the pressure rise is that the cooling water channel was not re-open after partial removal work of cooling water.

Joint between the coupling cavity and storage cavity

**D05-A and -F cavities are normal and will return to operation without cavity replacement.**  
→ This will contribute to higher beam current!

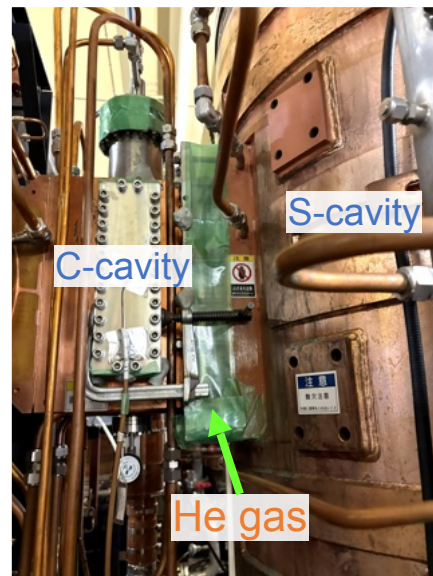
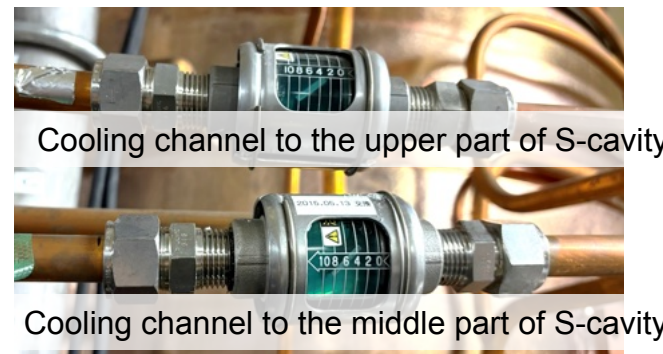
Flap flow meters

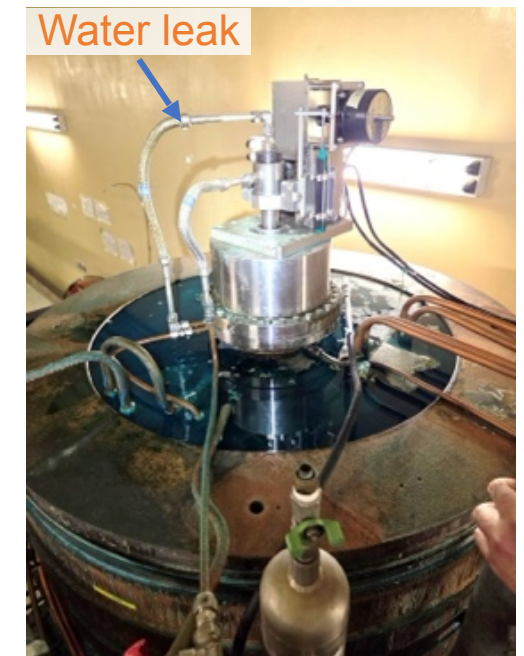
Cooling water leak at D05F cavity

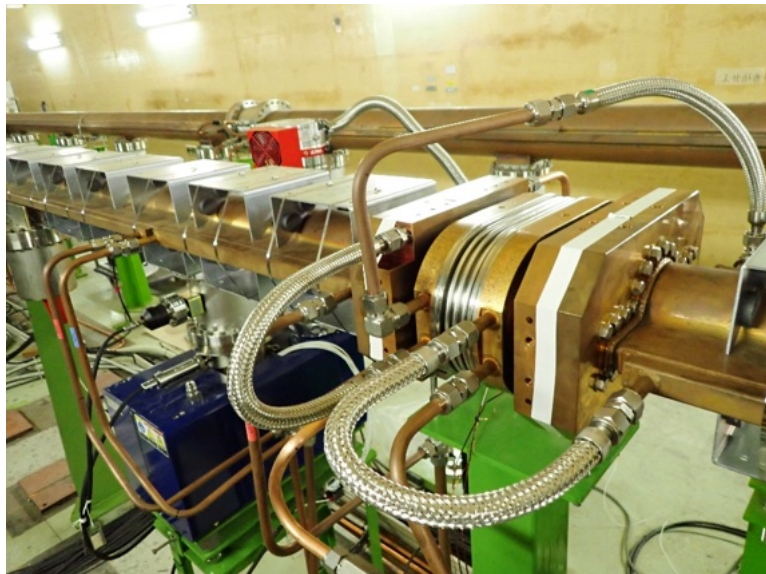
Bellows chambers with reinforced water cooling

- Wiggler part
  - ✓ Countermeasures against vacuum leak
    - Bellows chambers with reinforced water cooling
      - Reduction of vacuum leak risk at high current
- Replacements of the collimator jaws
  - ✓ D03V4
  - ✓ D05V1
- Replacement of QI6P chamber (injection point)
  - ✓ Improvement of injection efficiency is expected.

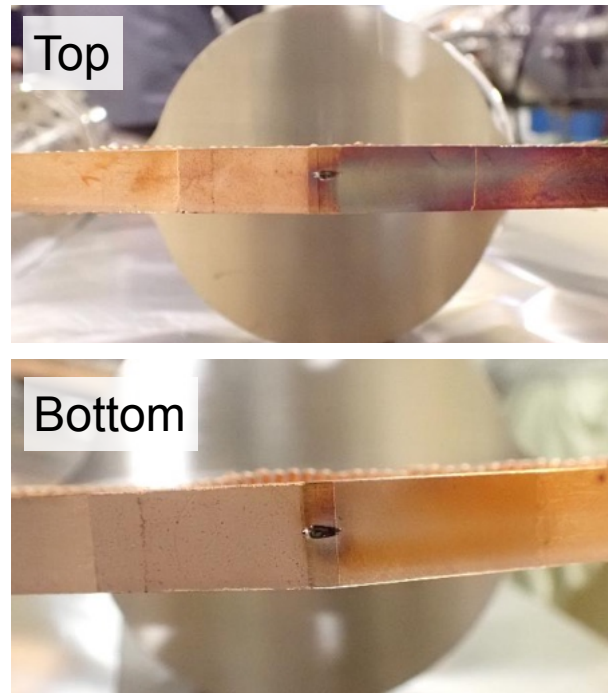
Damaged collimator jaws (D03V4)

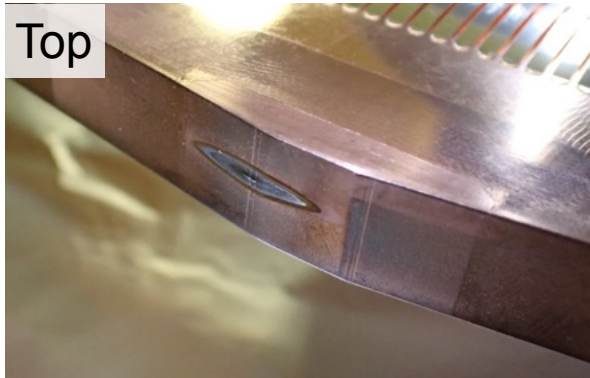
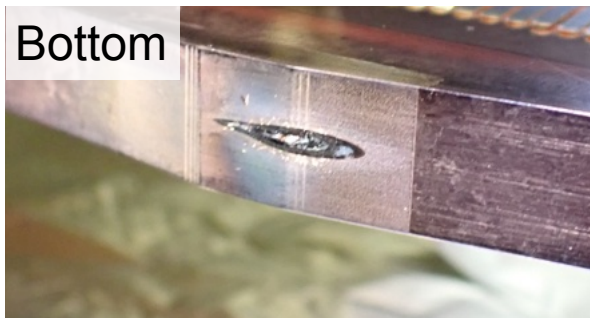
Damaged collimator jaws (D01V1)

- Replacement of the collimator jaws
  - ✓ D01V1
- Installation of the new D09V1 collimator with water cooling channel
- Repair of ZVF4RE stainless-steel beam pipes
  - ✓ Large vacuum leak occurred in 2026ab run.
  - ✓ Fabrication of a new chamber underway

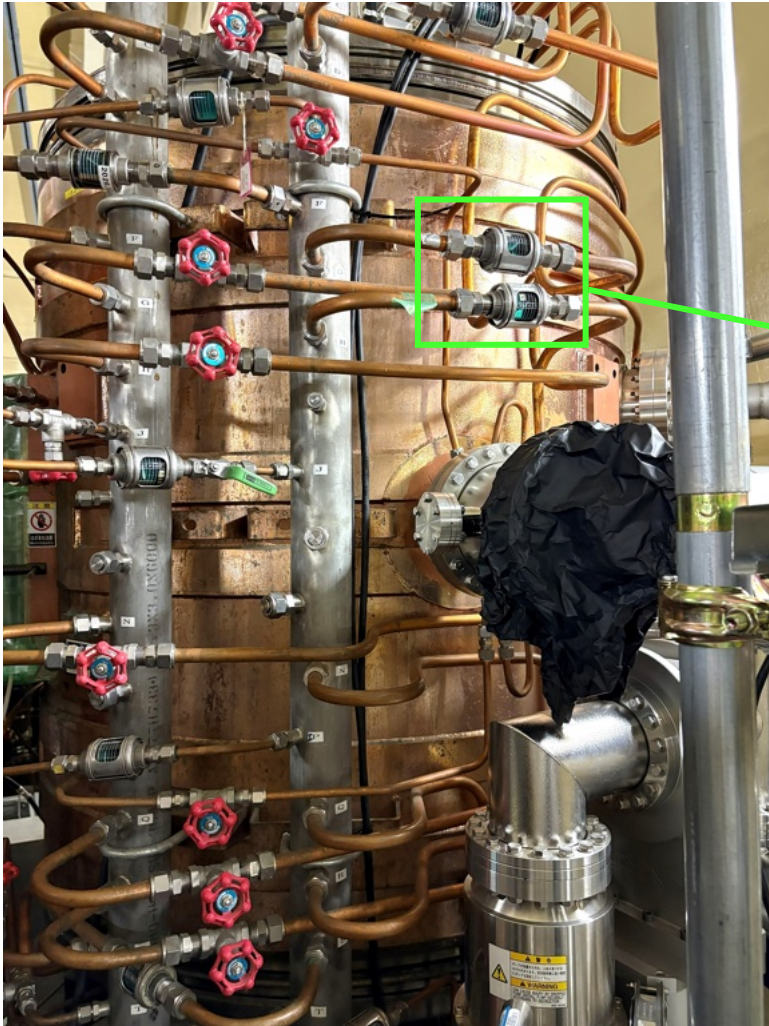
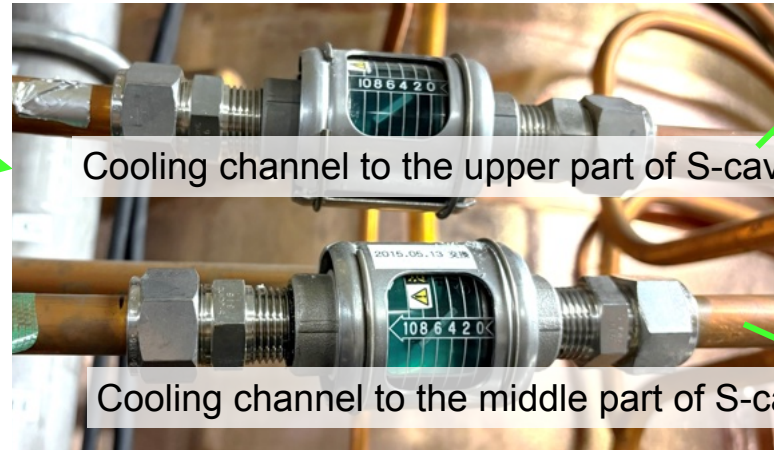
- By **obscure failure of a flap flow meter**, cooling water flow was insufficient at the middle part of the storage cavity.
  - Thermal expansion led to vacuum leak at the joint.

**Flap flow meters**

- ✓ By obscure failure of a flap flow meter, cooling water was insufficient.
- ✓ Thermal expansion induced vacuum leak at the joint between the coupling cavity and storage cavity.
  - Adjustment of cooling-water flow should not rely on the flap flow meter but on opening valve of each valve (flap flow meters used as reference only).

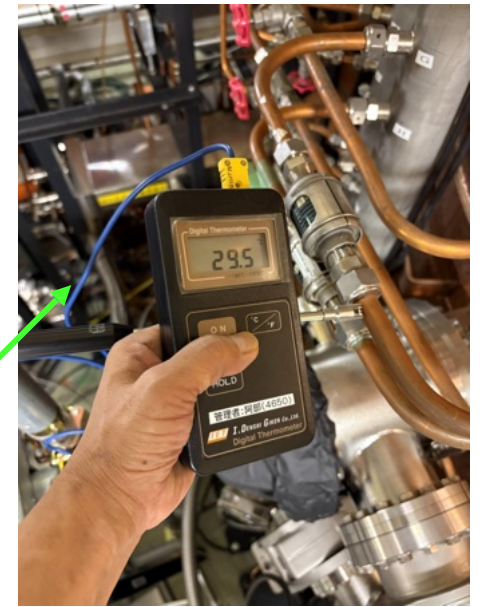
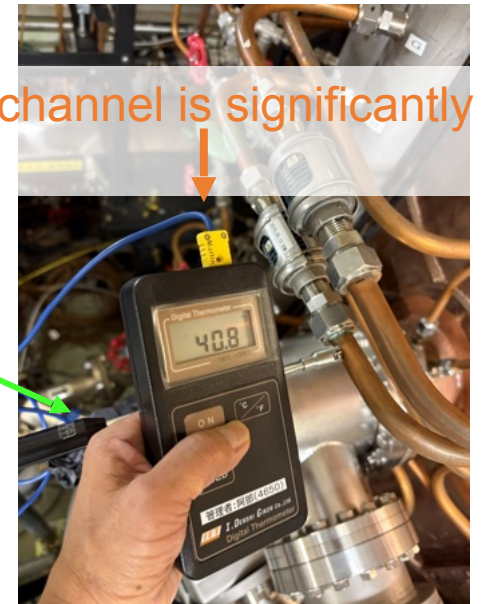
- ✓ With the normal cooling water flow, we have confirmed no vacuum leak at the joint during high-power operation with maintaining  $V_c = 0.5$  MV/cavity.

**Temperature measured  
17 min. after RF turned off** 27

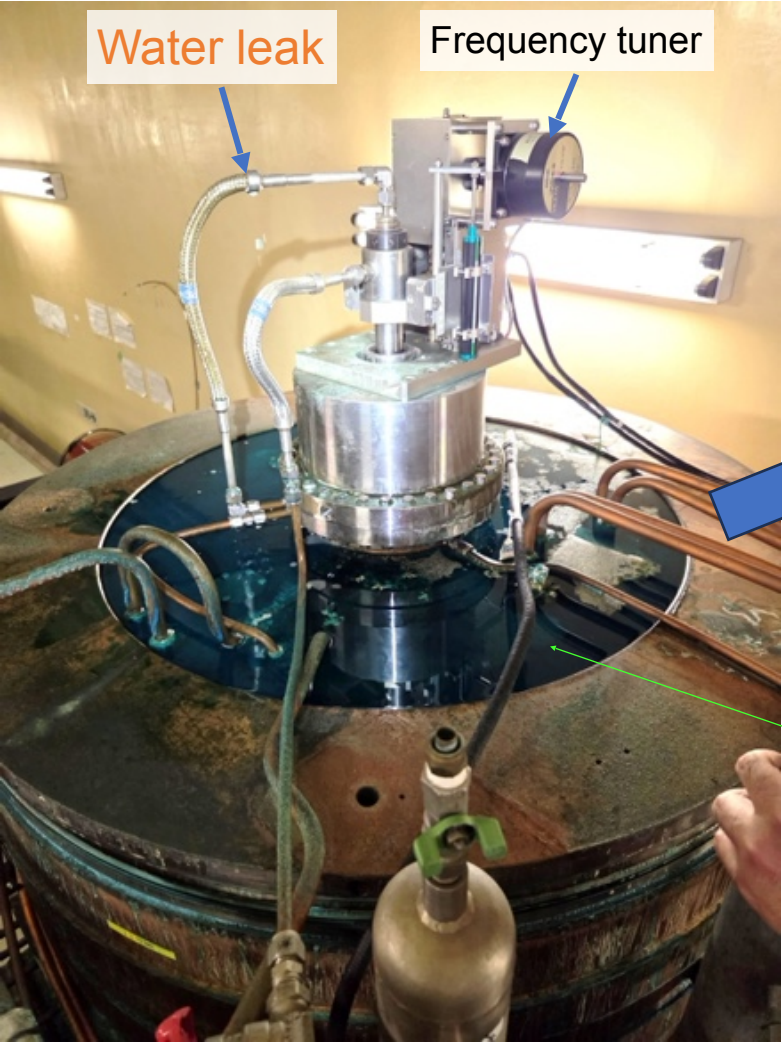
- On a regular maintenance day (Apr. 15, 2026), cooling water leak was found on the top of the storage cavity.
- After partial removal work of cooling water, cavity aging was conducted as usual. → **Abnormal vacuum-pressure rise** occurred.

Partial removal  
of cooling water

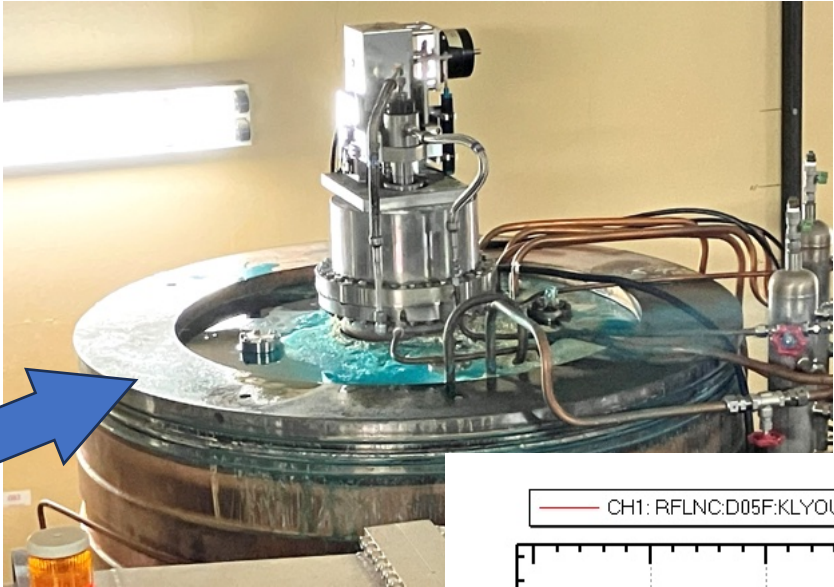
Cooling water including rust inhibitor  
(the storage cavity is made from iron)

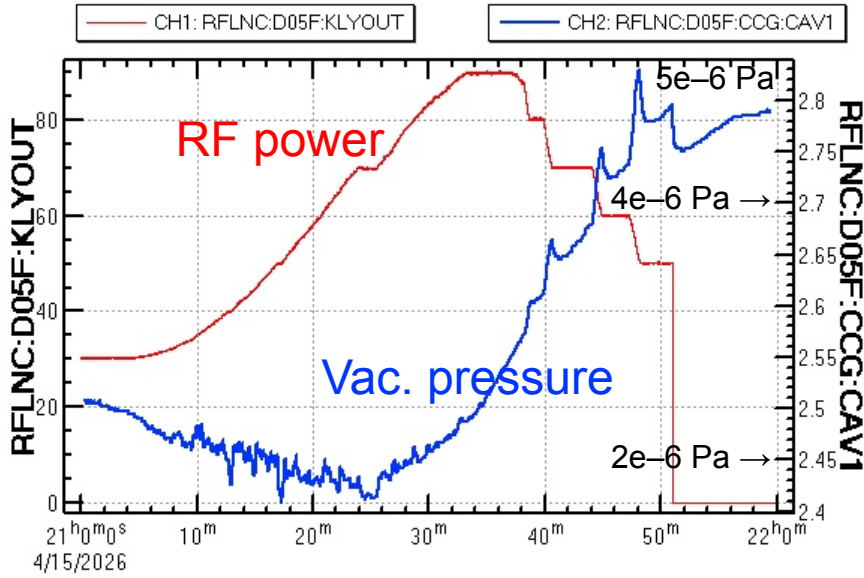
Vacuum leak during cavity aging

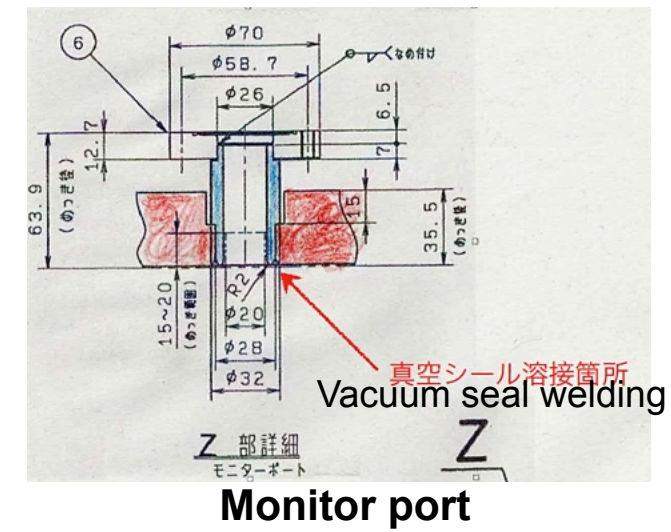
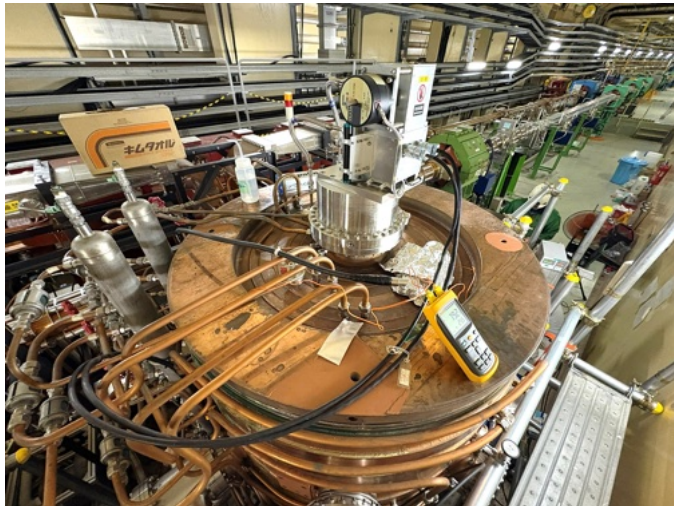
- During this summer shutdown, investigation on D05F was conducted parallel with that on D05A.
- ARES cavity group first suspected **galvanic corrosion** between the monitor port (stainless steel) and cavity main part (carbon steel).
- They conducted the following tests:
  1. Cleaning work (Jul. 3, 2026) → Baking of the monitor ports at 80°C
  2. Leak test without RF input → no leak found
  3. Leak test with RF input → no leak found
  4. Injected acetone and ethanol → leak test → no leak found
  5. High-power test at the RF voltage of 0.5 MV → no leak
    - In the investigation of D05F, **the pressure rise could not be reproduced!**
  6. Observed the cavity inside → nothing wrong

D05F Cavity after cleaning

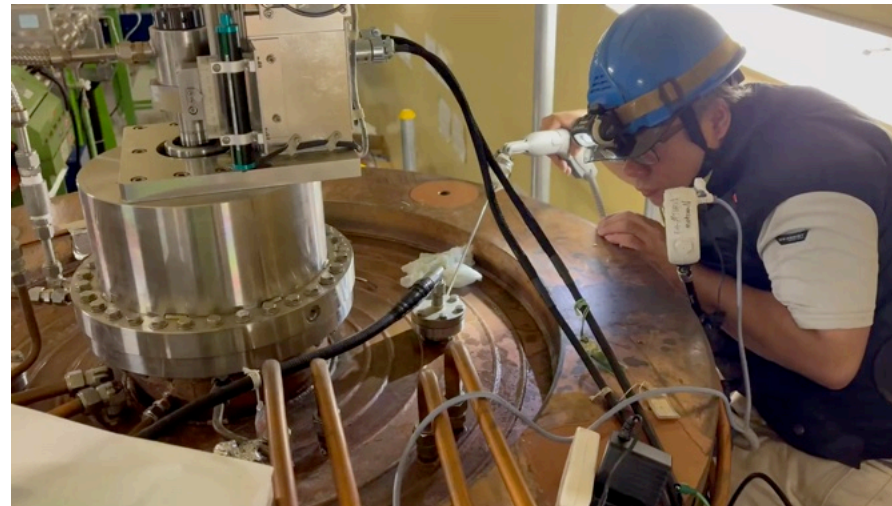
Solvent injected to the root of the monitor port

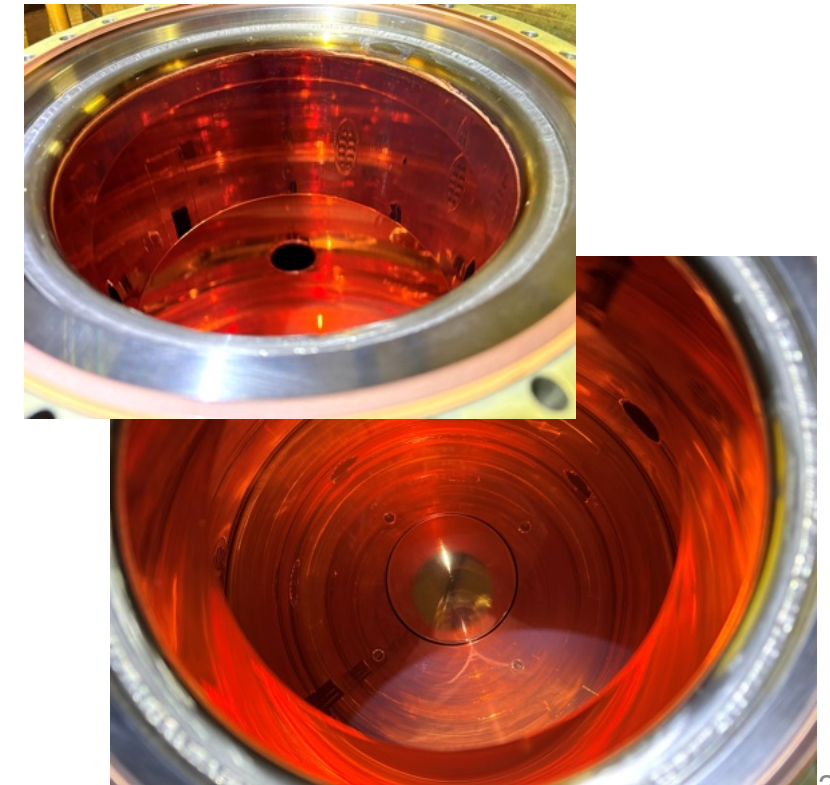
Cavity inside investigation
