Approach to the more stable injector linac for SuperKEKB

H. Ego

B2GM, June 17, 2019

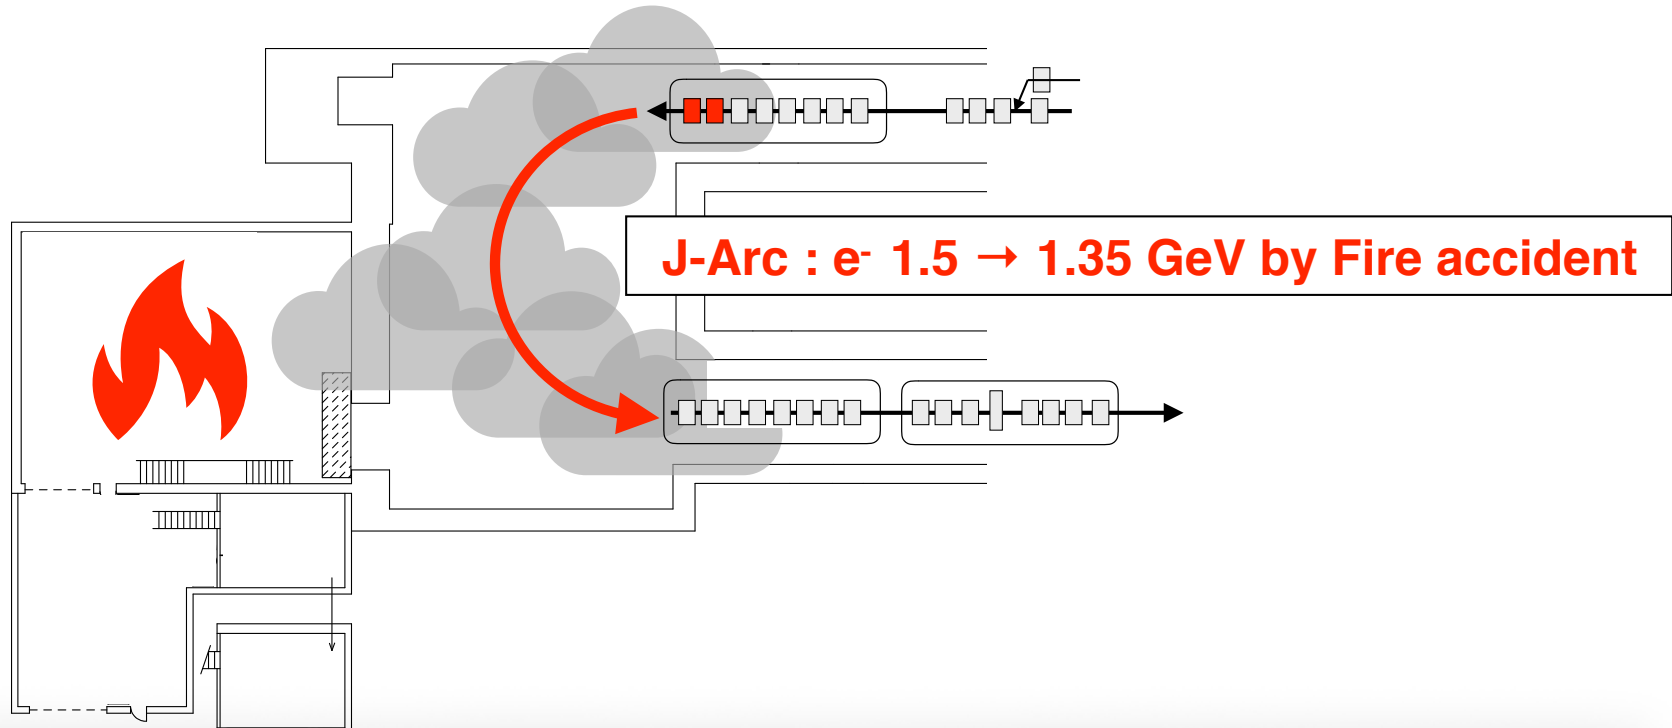
Fire in Accelerator assembly hall (Nextef)

Severe damages to the linac components in B- and C-sectors by soot attacks

First-aid procedures done
Entire recovery of Linac in this summer
for bending-magnet power-supplies and B-7,8 modulators

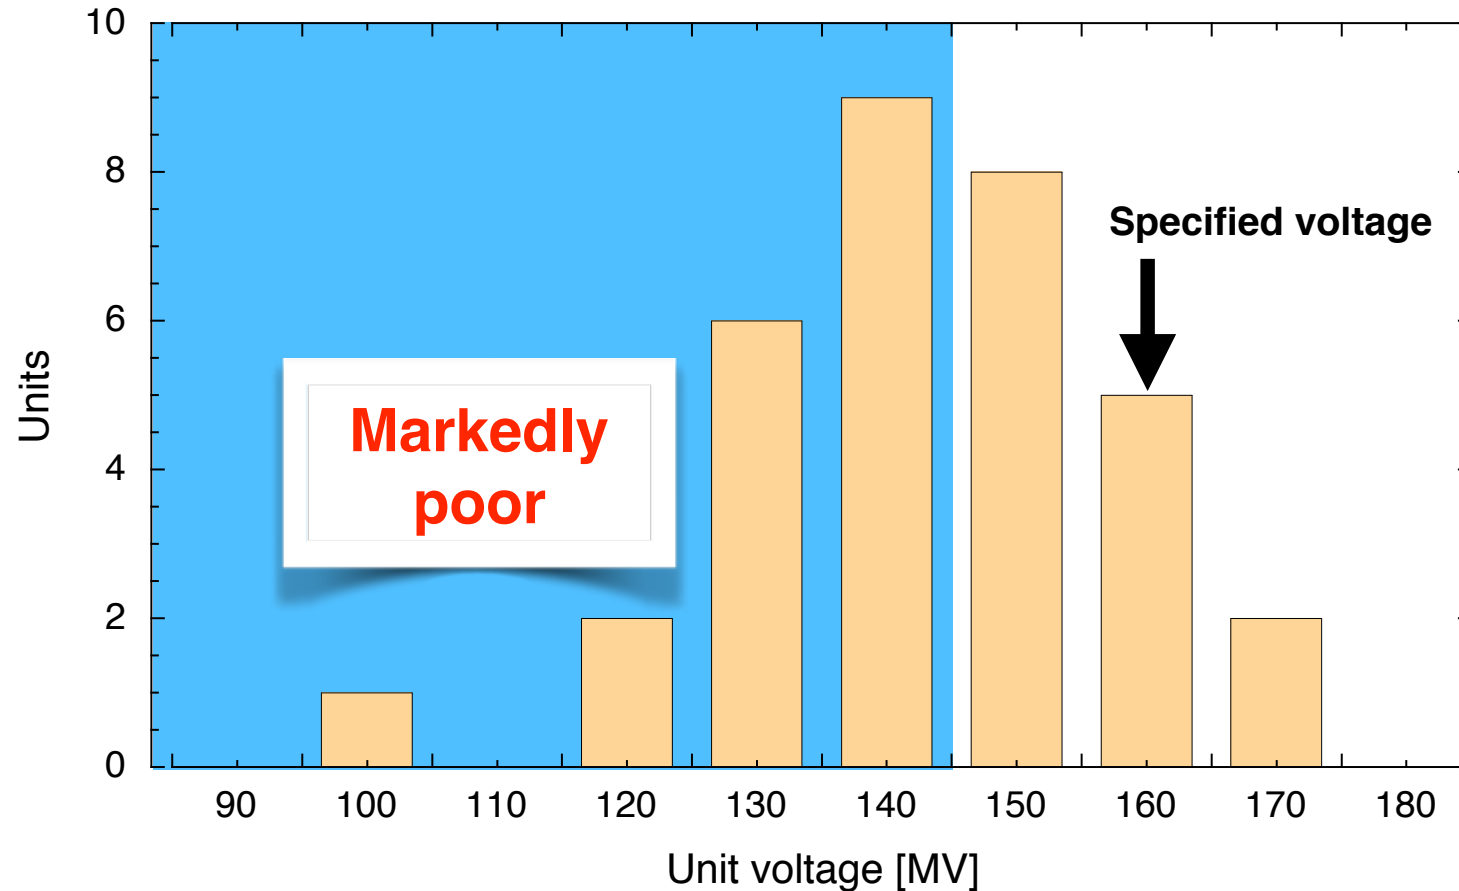
Many structures suffering from power reflection and/or excessive field emission

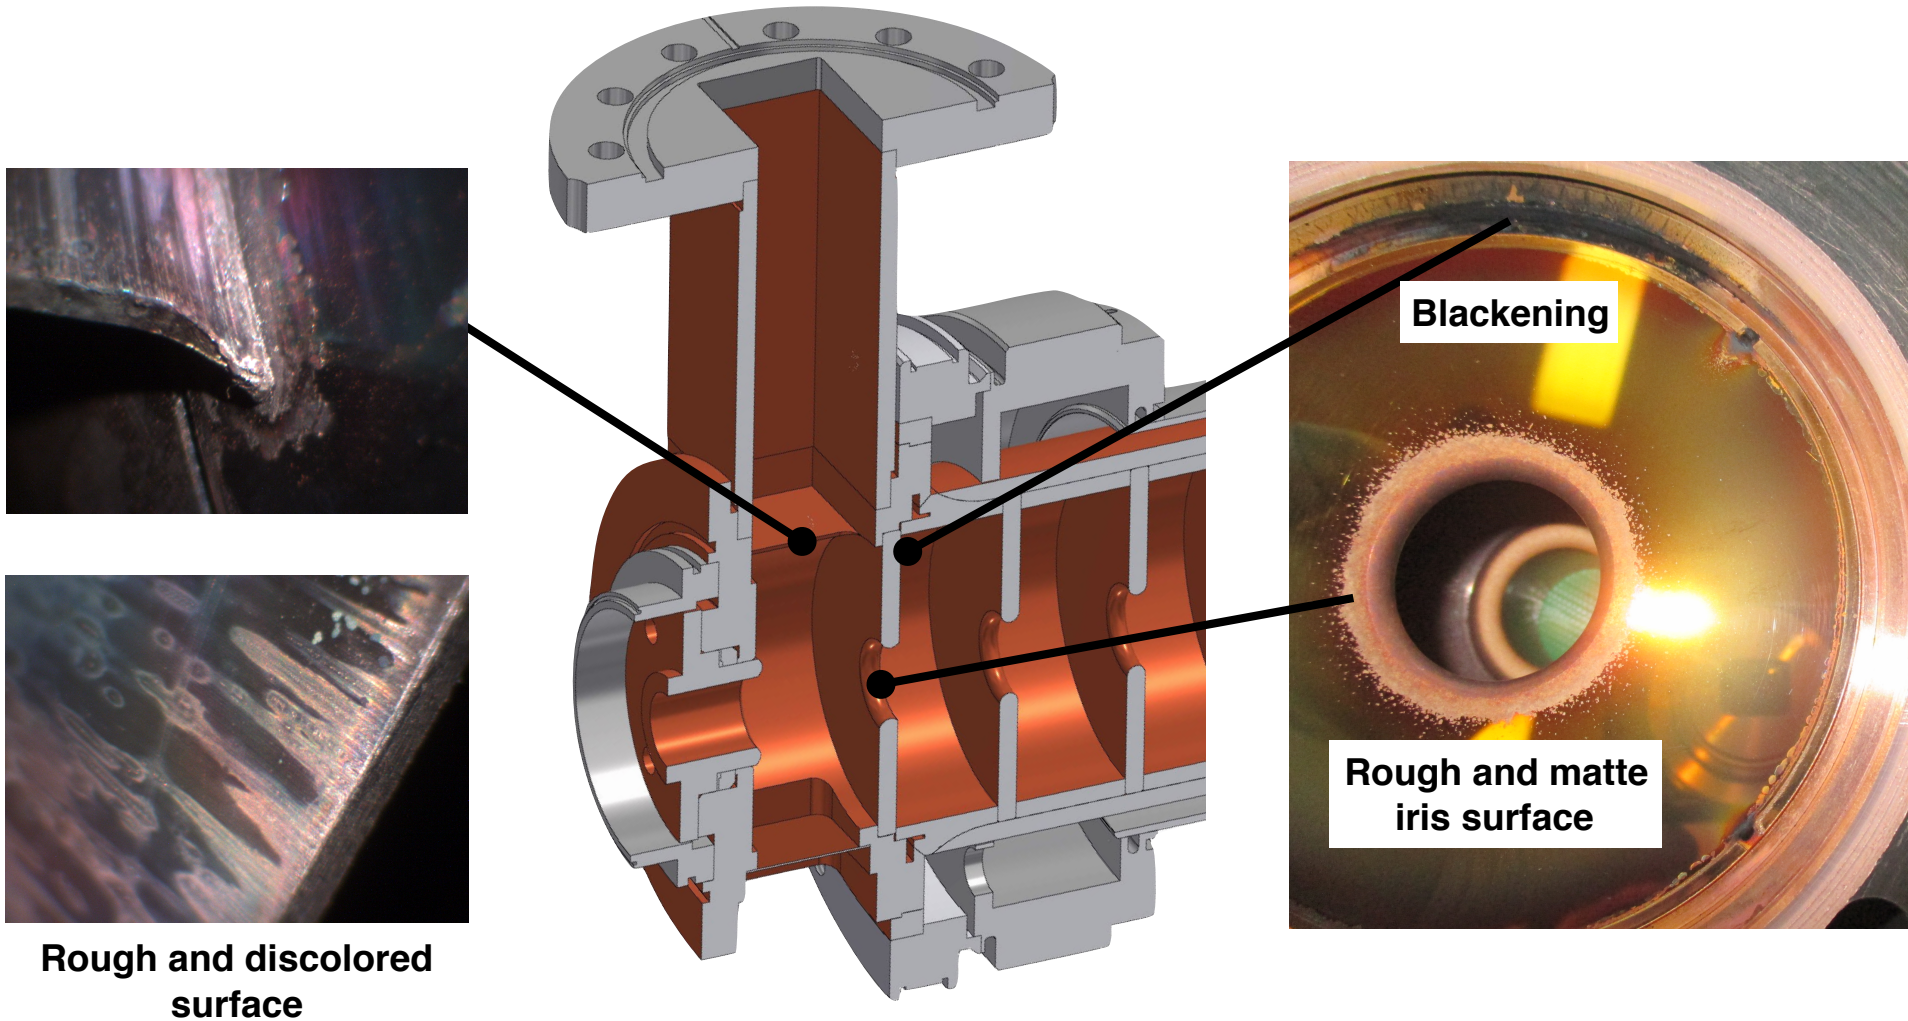
The couplers severely damaged !

Complete cure : new designed S-band structures

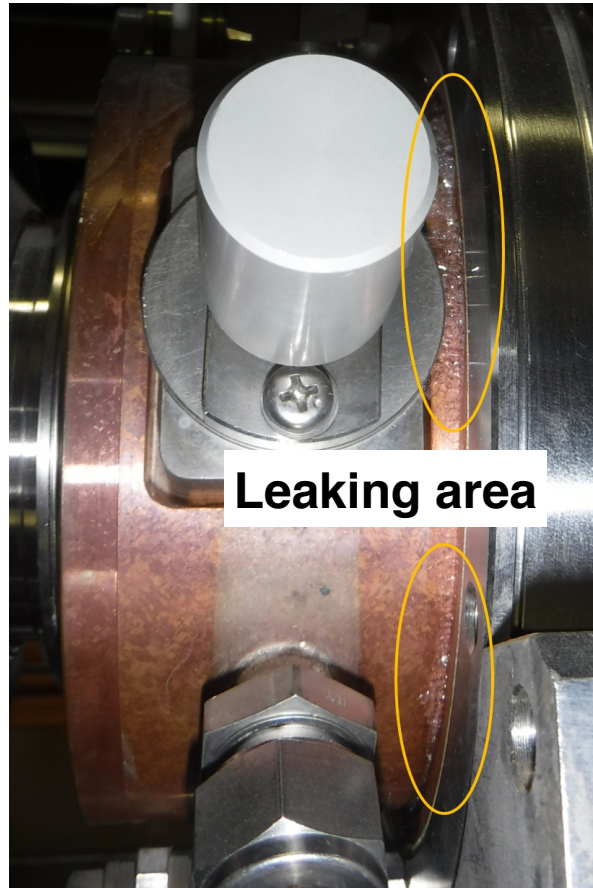
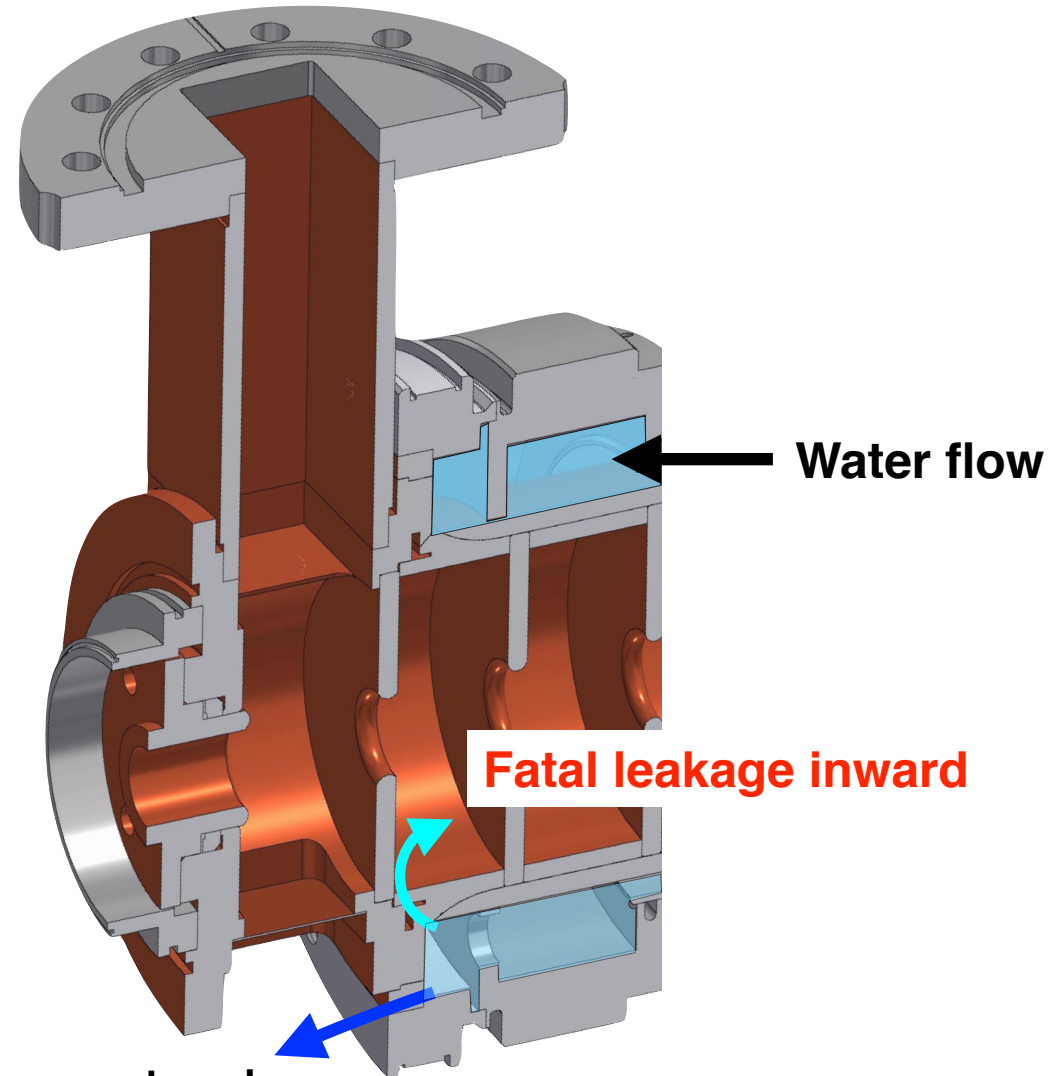
Fatal case : water leakage

Approximately three structures with water leak a year

Leakage outward
makeshift repair with sealants

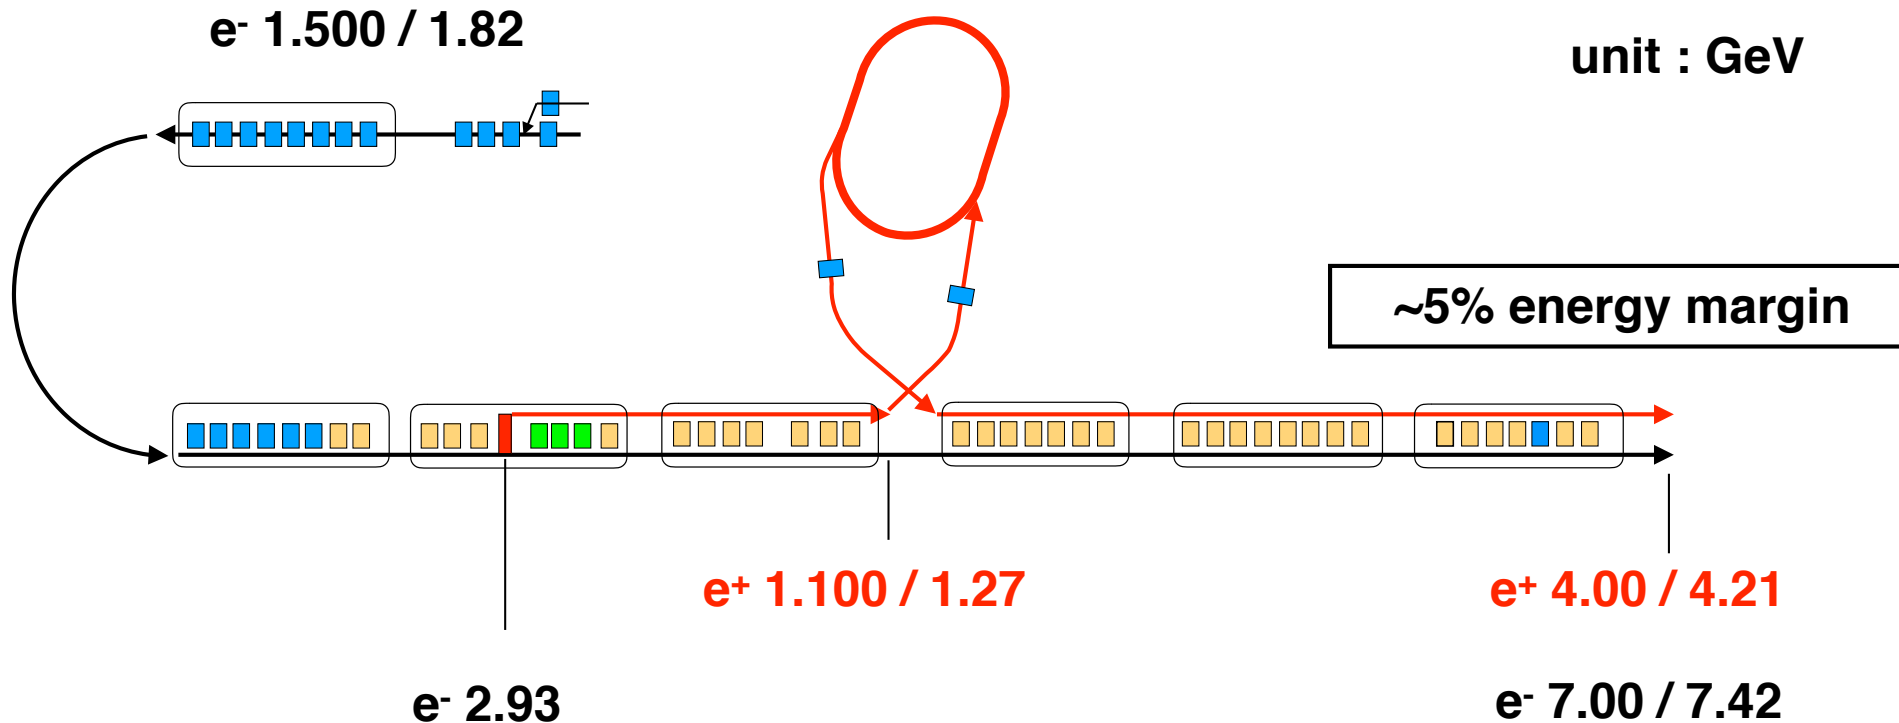
Energy map required energy and available maximum energy

No energy margin for the 6S operation at

e^+ 4.17 and e^- 7.29

with a beam charge of 4 nC

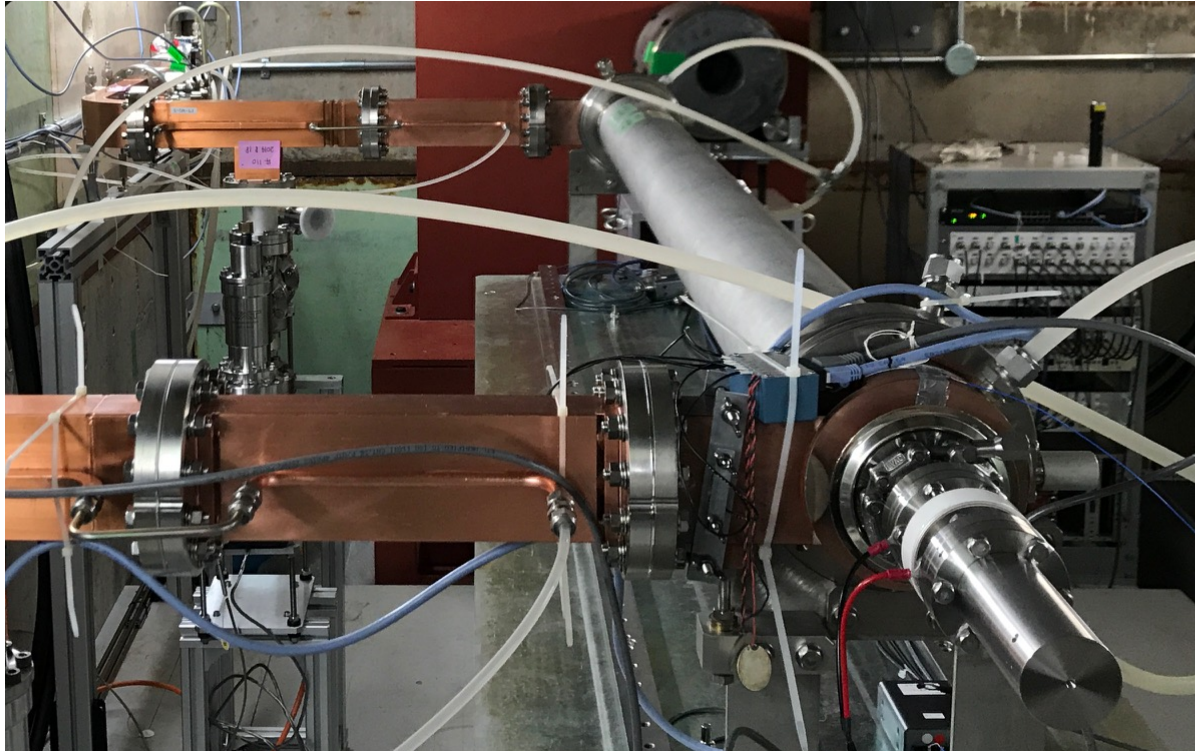
Spare structure under high-power check in the shield room

Spares also suffer from power reflection and excessive field emission
