SuperKEKB Shutdown Activities and Operational Plan for 2025c Run

B2GM

June 16, 2025

on behalf of SuperKEKB Commissioning Group

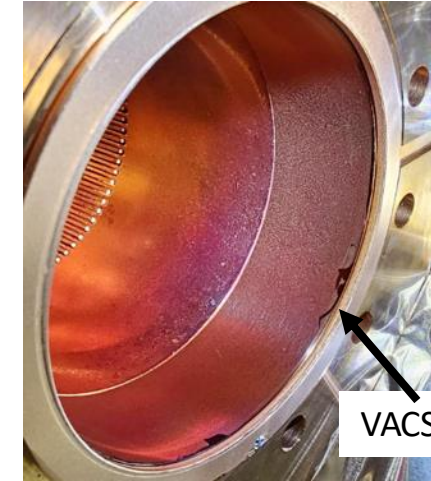
LER D01 Bellows Chamber

- VACSEAL was used on all flanges in the IR during construction.
- We removed the VACSEAL from all MO-flanges and reinstalled them without using it.
 - LER: 23 MO-flange connections (11 bellows chambers + 1 flange connection)
 - HER: 18 MO-flange connections (9 bellows chambers)
- The connections near the IP cannot be opened during this shutdown.
 - LER: 8 HELICOFLEX-flange connections remain uncleaned (2 bellows chambers on each side closest to the IP)
 - HER: 8 HELICOFLEX-flange connections remain uncleaned (2 bellows chambers on each side closest to the IP)
- No evidence of VACSEAL intrusion into the beam channel (e.g., black stains) has been observed so far with HELICOFLEX flanges.
 - Experimental results have also confirmed that at a leak rate on the order of 1×10^{-9} Pa·m³/s, VACSEAL does not intrude into the beam channel.

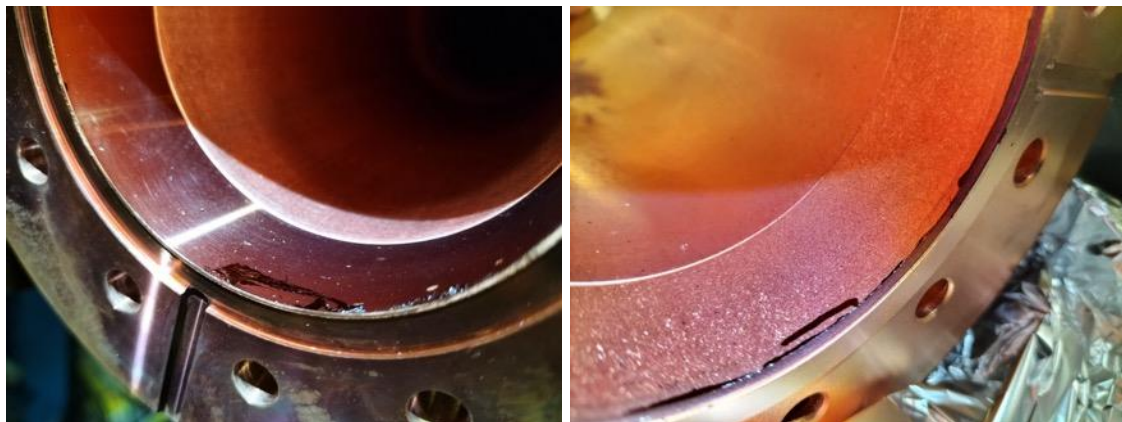
Inside of beam pipes near CCG D02_H23

- A black stain was also found near the vacuum gauge CCG D02_H23 in the HER IR, where pressure bursts associated with beam aborts had been frequently observed.
- Additionally, an inspection of the inside of the QCS beam pipes using a fiber scope were performed. In particular, the surface on the HER D02 side showed discoloration—areas that were supposed to be copper-plated had turned black.
- The vacuum gauge closest to the IP had been CCG D02_H23. To better observe where the pressure bursts occur, a new vacuum gauge, CCG D02_H24, was installed closer to the IP.

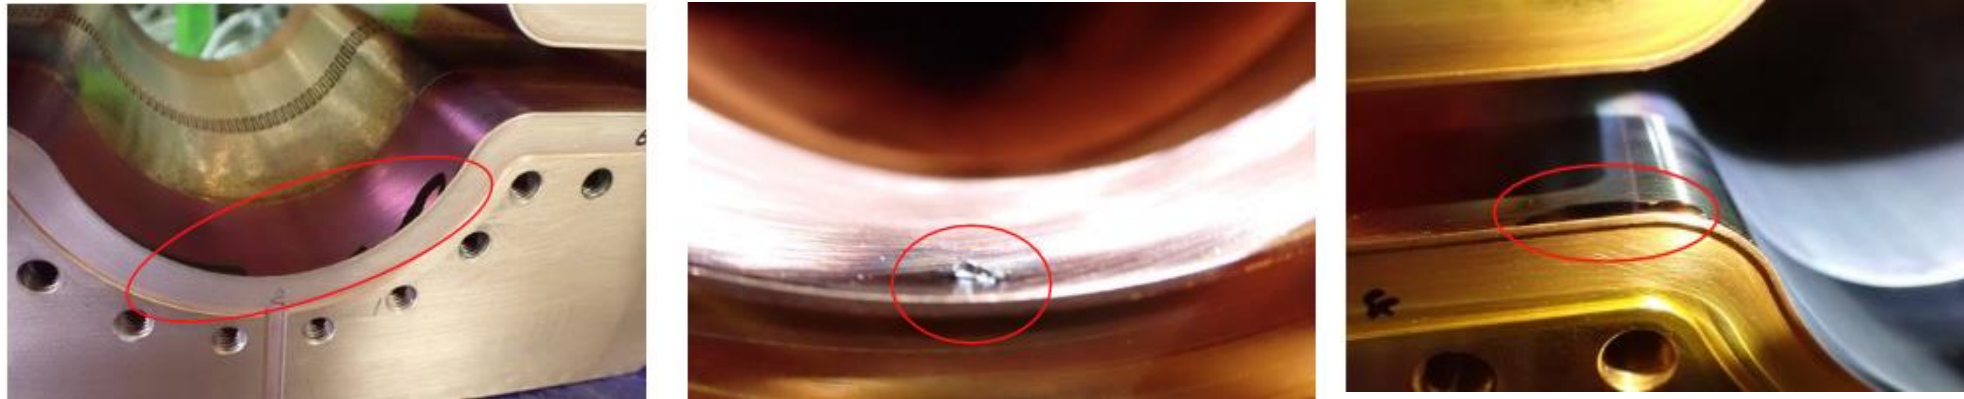
Inside of bellows chamber and beam pipe in the Oho Wiggler Section

- We removed and inspected all of the bellows chambers in the Oho wiggler section.
 - 52 MO-flange connections (26 bellows chambers)
- Some bellows chambers and beam pipes showed black stains.
- We removed them and reinstalled the chambers without using VACSEAL.

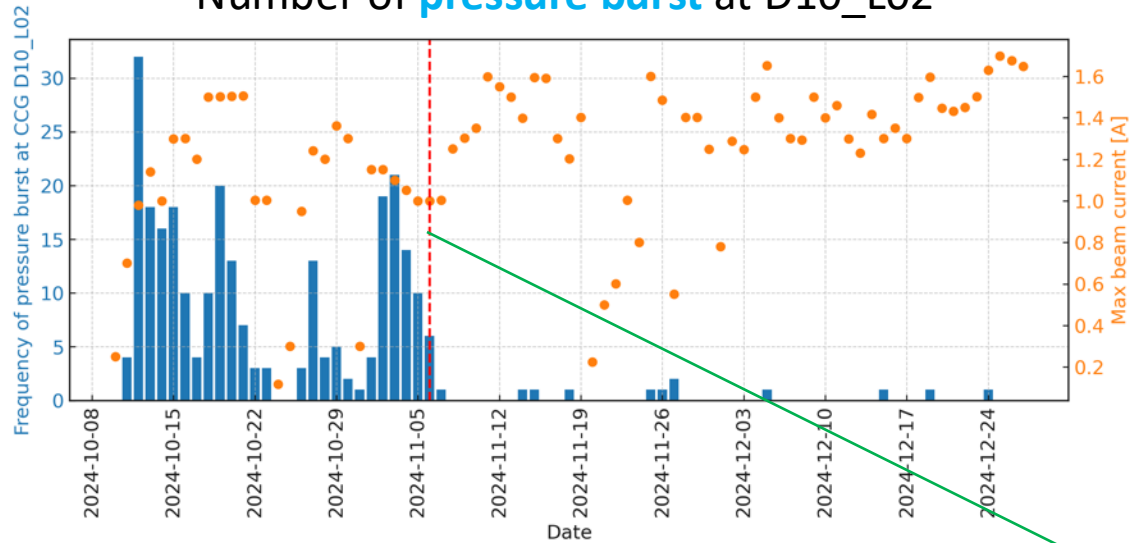
Number of **pressure burst** at D10_L02

- A bellows chamber near CCG D10_L02 was replaced, and VACSEAL was removed from the adjacent beam pipes on Nov. 6 during the 2024c run, using the same cleaning method.
- After this work, the number of pressure bursts in the area has been significantly reduced.

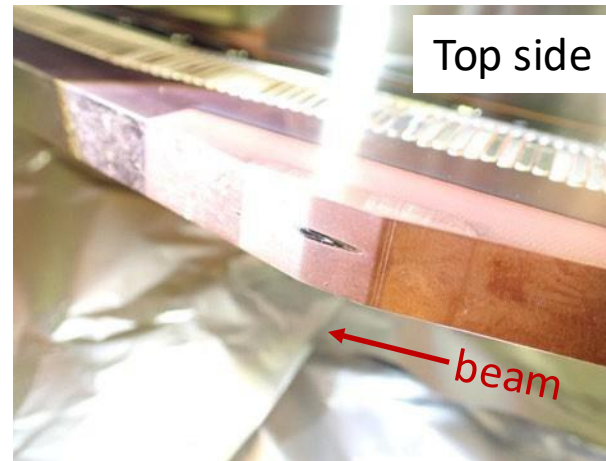
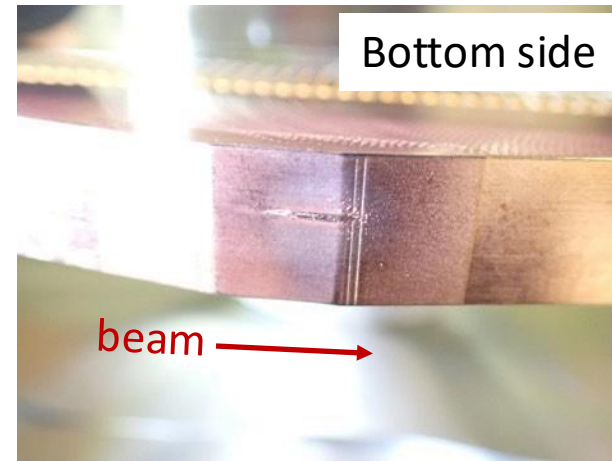
Damaged jaws removed from D02V1 (Ta, 10 mm)

- Damaged jaws in D02V1 and D05V1 were replaced with new ones.
- The top jaw removed from D05V1 was replaced, although its flat area at the tip appeared undamaged and still usable.
- We installed a Ti jaw on the top side of D05V1 to test its durability and evaluate its background reduction performance.

- D02V1: Ta, 10 mm (both side)
- D05V1: Ti, 10 mm (top side)
Ta, 10 mm (bottom side)

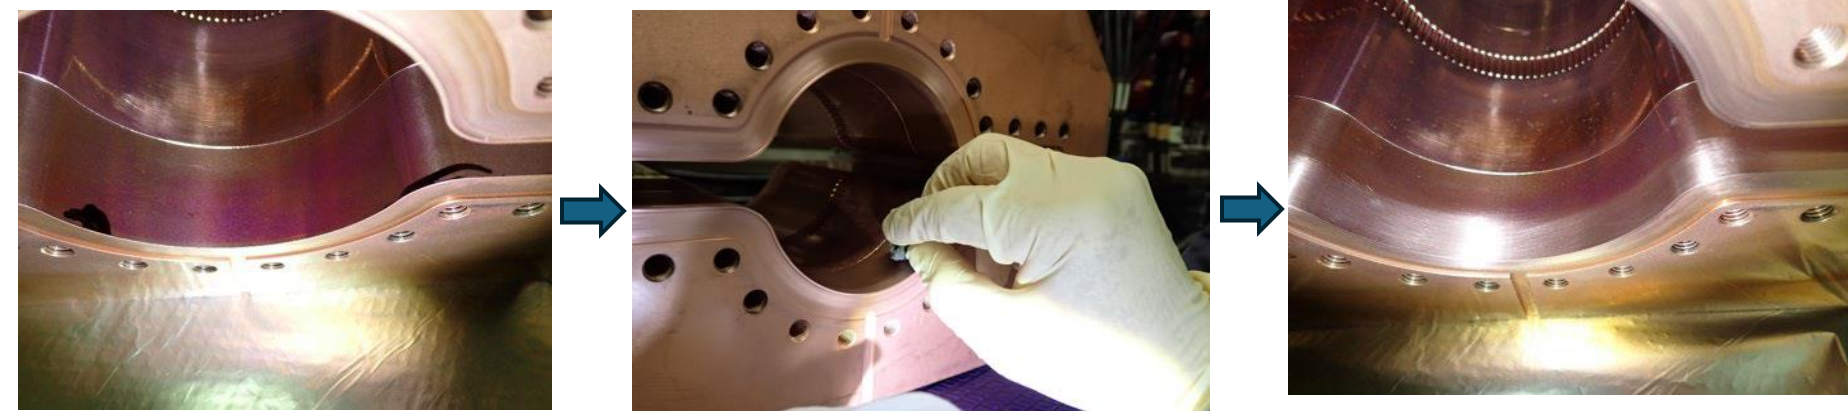
Bellows chamber

- The black stains caused by VACSEAL cannot be removed ethanol-soaked wipes alone.
 - Some black stains have a flaky structure and tend to detach easily.
- The inside surfaces are polished with Scotch-Brite, then cleaned with ethanol-soaked wipes.
 - Beam pipes in the Q-magnets are coated with TiN, and part of this coating is also removed during polishing.
- This cleaning process is also applied to areas without visible black stains, since VACSEAL residues may be present in less visible forms.
- Powdery dust is found throughout the beam pipes, regardless of the presence of black stains. It is removed from accessible areas via the removed bellows chamber openings.
- All flanges are labeled, and work records including photos are documented.

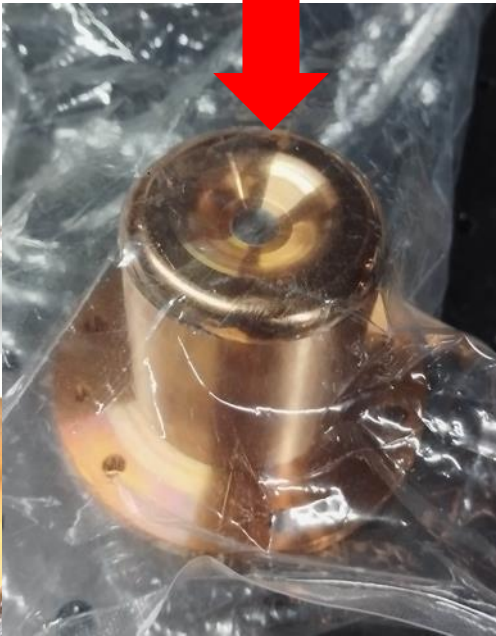
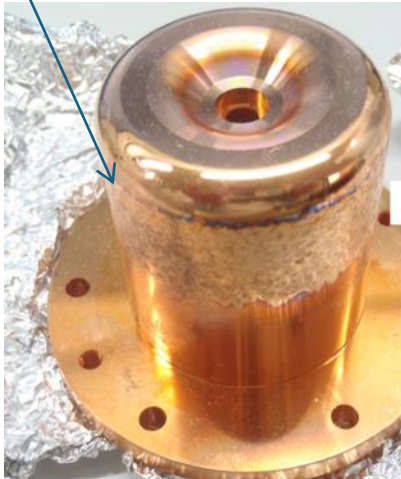
Discharge was observed due to the choke structure
