VACUUM PROBLEMS OF RF CAVITIES
IN THE PF STORAGE RING

M. Izawa, Y. Kamiya, H. Kobayakawa,
S. Tokumoto and Y. Yamazaki

National Laboratory for High Energy Physics
Oho-machi, Tsukuba-gun, Ibaraki-ken, 305, Japan

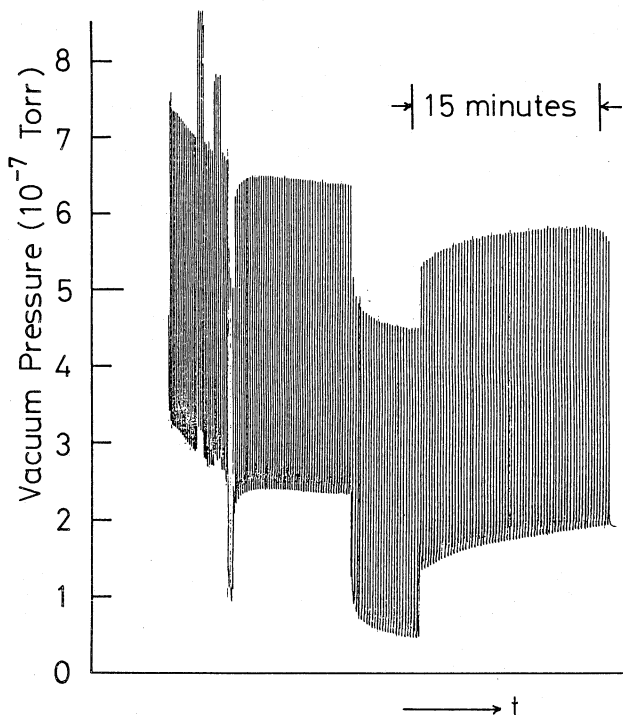
A trouble of the vacuum occurred on a cavity during the conditioning with high RF power. The ionisation vacuum gauge placed at upstream of the cavities showed the sudden increase of the pressure up to the range of 10^{-6} Torr followed by the periodic change of the pressure as shown in Fig. 1. The oscillating structure recorded in Fig. 1 has a period of about 8 sec in the beginning, which increases gradually up to 11 sec. The amplitude was almost constant unless the pumping speed of the evacuation system was changed. This phenomenon repeated intermittently as shown in Fig. 2.

A mass spectral measurement on the residual gases was made. The mass spectra were obtained on a ANELVA model AQA-100 MPX quadrupole massfilter which was placed near the ionisation gauge. It was found that the peaks at m/e of 14, 18, 28, 32 and 40 became high when the pressure increased. These peaks may be assigned to N_2 , H_2O , N_2O_2 and Ar, respectively. The result suggests that the increase of the pressure is due to the leak of air.

Fig. 1 The periodic change of the pressure near cavity recorded by the ionisation vacuum gauge.

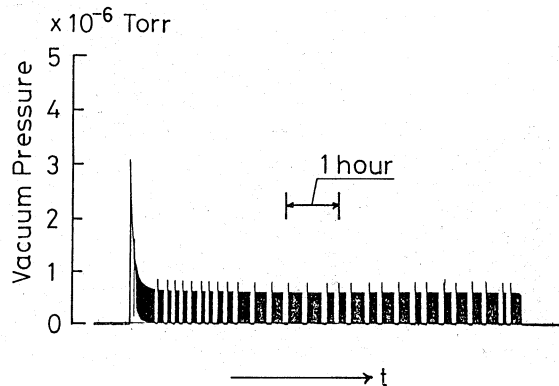
Fig. 2 The periodic change of the pressure recorded for several hours.

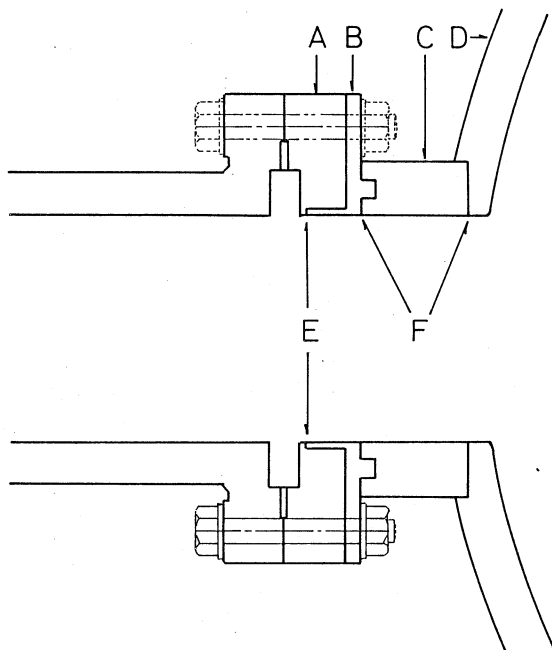
Because we could never get rid of this leak, the cavity was exchanged for a spare. In order to probe the cause of the intermittent leak, a detailed investigation of this leak was made. Figure 3 shows the structure of the housing. The housing is composed of three pieces. A port made of copper, C in Fig. 3, is silver-brazed to the cavity body. A nickel-coated transition piece (stainless steel, B in Fig. 3) is silver-brazed to the port. A stainless steel vacuum flange is helium-arc welded to the transition piece.

Fig. 3 Schematic drawing of the housing of the tuning plunger. A: vacuum flange, B: transition piece, C: port, D: cavity body, E: He-arc welded part, F: silver-brazed parts

The housing of the tuning plunger has somewhat complicated structure so that it is difficult to detect or get rid of a leak. It is necessary to cool the tuner flange with water. Following improvements on this part are progressing: (1) The nickel-coated piece, B in Fig. 3, will be removed. (2) Inner side of the flange, A in Fig. 3, should be made of copper.

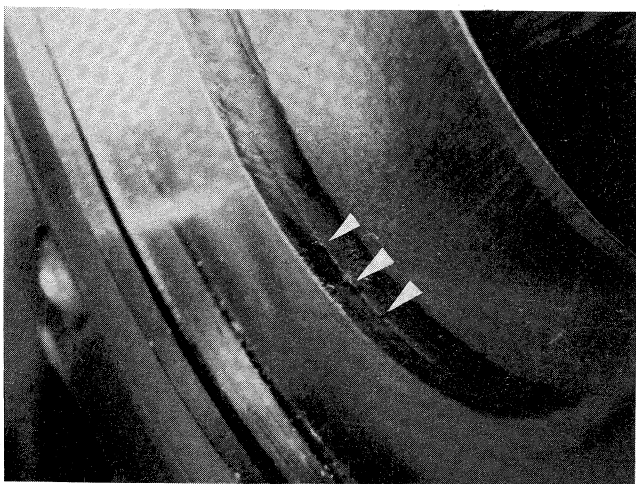
The leak detection indicated that the leak was located at the vacuum flange and its neighborhood. We found finally that oil-like liquid exuded on the surface of the vacuum side of the welded part between the vacuum flange and the transition piece as shown in Fig. 4.

Fig. 4 Photograph of the tuner flange. The oil-like liquid is seen at three points.

The reason for the periodic leak of air might be explained as follows: (1) The pin holes opened at the welded part during the conditioning of the cavity. (2) The welded part had the cracks filled with oil-like liquid. (3) Air penetrated in the liquid and a bubble formed. (4) When the pressure of the bubble exceeded the surface tension of oil-like liquid, the bubble break and then the leak occurred.

The vacuum flange and its neighborhood mentioned above is heated by the RF field. The formation of the cracks or pin holes might be due to thermal fatigue.

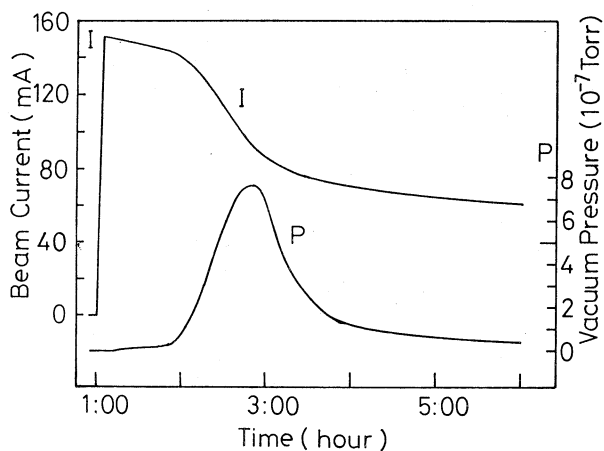
Another vacuum problem is the deterioration of the pressure near cavities which gives an important influence upon the beam lifetime. Figure 5 shows an example that the increase of the pressure near cavity causes the beam lifetime to shorten. The pressure, P in Fig. 5, increases abruptly up to the range of 10^{-7} Torr about one hour after the beam accumulation of 150 mA. The beam current, I in Fig. 5, decays rapidly with the increase of the pressure. The lifetime is shortest when the pressure reaches its maximum, and then, recovers as the pressure decreases. This phenomenon does not occur every time. The pressure remains mostly 4×10^{-8} Torr or lower. In this case, the rapid decay as seen in Fig. 5 is not observed.

Fig. 5 An example of lifetime shortening due to the deterioration of the pressure near cavities.

The deterioration of the pressure depends upon the bunch filling structure around the ring. It occurs more frequently when the filling shape of RF buckets is more sharp. Therefore it probably relates to the wake fields induced by the bunched beam. The wake fields may heat some part of cavity and make degassing. The temperatures were measured at the several points of the tuner flanges and the beam ducts. It was found, however, that there was no correlation between the vacuum pressure and the measured temperatures.
