# ELECTRON-LENS TEST STAND INSTRUMENTATION PROGRESS\*

## Abstract

In preparation for installation of Electron Lenses [1] into RHIC, planned for late 2012, a working test stand (or “test bench”) is in use testing the performance of the gun, collector, modulator, instrumentation and controls. While testing & operating the instrumentation, both progress and pitfalls were encountered. Results are presented from issues including ground loop signals generated by the DCCTs, static magnetic field interference, competing YAG screen illumination techniques, YAG crystal damage during beam operation, performance of the four quadrant beam scraper electrodes, and challenges in measuring beam current in conductors. Working knowledge and insight into each of these systems has been gained through difficulties leading to success. These insights are presented with supporting data and images.

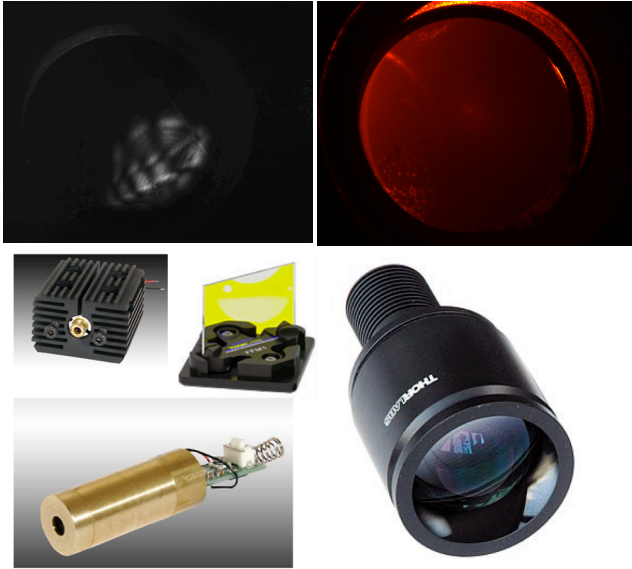
Figure 5: YAG fluorescent illumination. **Left:** 405nm laser spot on YAG crystal via camera lens, pictured above laser module, heatsink, and beam splitter; and **Right:** YAG crystal (shown in red scale for contrast) flooded with 455nm light, pictured above the projection LED.

White light illumination is provided by a collimated LED source [5]. Illumination at wavelengths that produce YAG fluorescence has been added. This provides a method to periodically test the health of the YAG crystal in situ. The optics layout in Fig. 3 shows the placement of a 500nm dichroic longpass beam splitter (1.1mm thick), Edmund Optics NT47-421, placed in the space between the camera and lens. This is used to project an enlarged 405nm laser spot onto the YAG crystal via the camera lens for focus determination and an in situ health check of the crystal. An image of the enlarged laser spot on the YAG crystal is shown in the upper left corner of Fig. 5. The 4mm laser oval laser beam is expanded by the camera lens to a 11mm spot on the YAG 1.3m away.

The first dichroic beam splitter used, as shown in lower left corner of Fig. 5, was a thicker (3mm) model from Thorlabs. This thicker glass between the lens and camera first required a refocusing of the lens due to the longer effective path length, but finally degraded the resolution to a degree that appeared grossly out of focus. The much thinner 1.1mm optic from Edmund Optics was installed; yielding a resolution measurement of 34 $\mu$ m.

The laser used is a 5mW GaN diode laser, commonly found in Blue Ray players and now in laser pointers. It was purchased from Beam of Light Technologies [6]. This laser module is supplied with integrated current driver electronics, as shown in the lower left corner of Fig. 5 along with its heatsink mount.
