Beam Abort Diagnosis

2022/10/31 BPAC

Contents

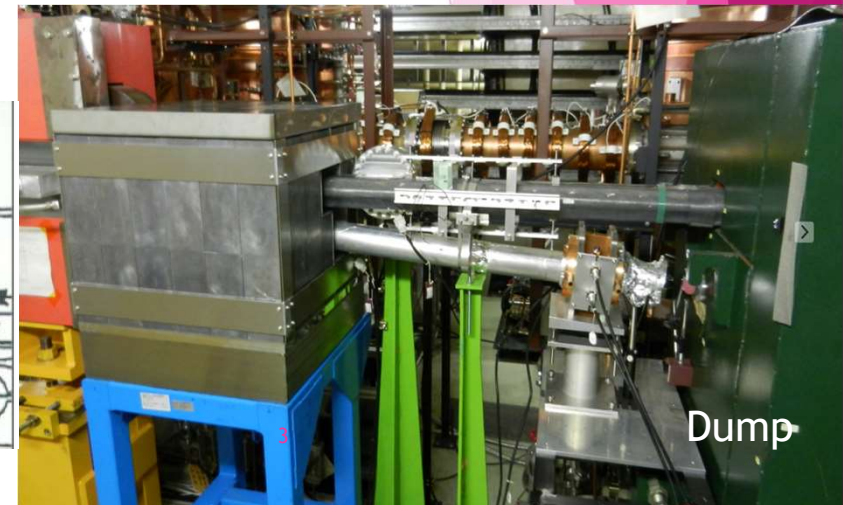
1. Abort System

- ▶ In order to protect the hardware components against the high beam currents, we installed the controlled abort system.
- ▶ The beam is kicked by an abort kicker, taken out of the vacuum chamber through an abort window made of Ti, and thrown into a beam dump.
- ▶ Dumped beam length : one revolution time ($10 \mu\text{s}$).
- ▶ Build-up time of the abort kicker magnet : 200 ns (empty bucket space).
- ▶ Synchronization of the kicker timing and the abort gap is required for the protection of hardware.

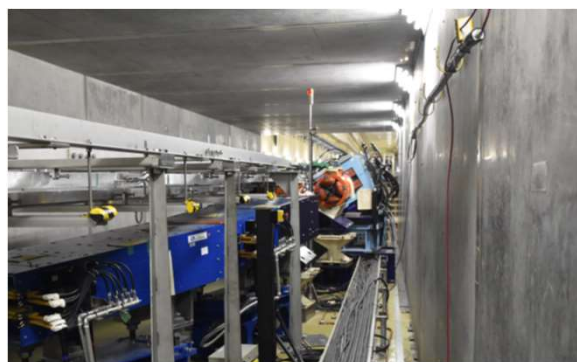
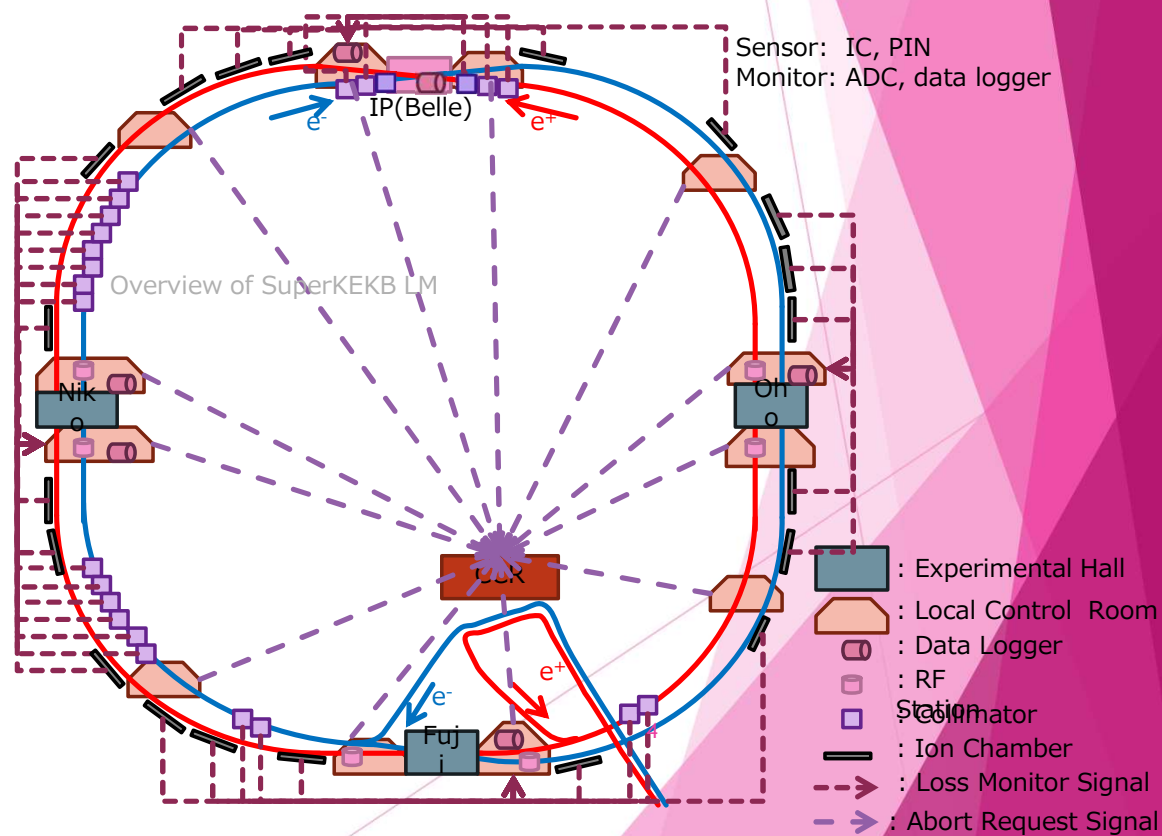
Loss Monitor System

- Measure the beam loss
- Used for
 - triggering the **beam abort** kicker
 - tuning and analysis of the beam operation
- No. of Sensors : 200
- **Ion Chamber**: Cover a wide range in space.
 - Put to cable lack of all over the tunnel to cover a wide range in space.
 - Free Air Ion Chamber (20D co-axial cable)
- **PIN photo diode**: Fast response and identify the ring in which the beam loss occurred.
 - Trigger generation time for beam abort in integrator : $< 2\mu\text{s}$
- **Optical Fiber** ← **New !**

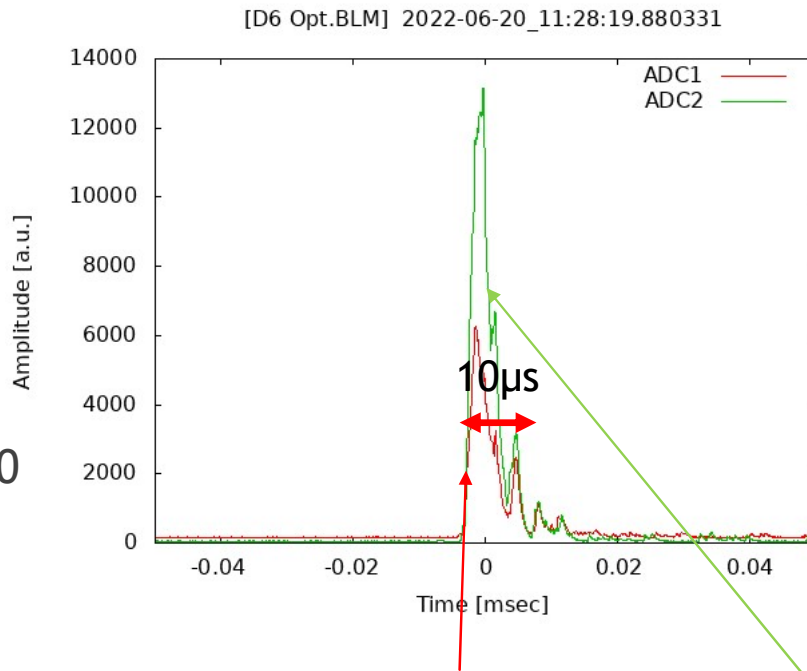
New sensor : Optical fiber

- ◆ The cause of the beam loss is unknown, but when the loss occurs, abort requested from the LM of downstream of collimator, Belle diamond, CLAWS, and also RF arc sensor.
- ◆ Since the loss monitor signal is sent to five LCRs around the ring, the cable length is not the shortest.
- ◆ **In order to send abort signals at the minimum distance**, a optical fiber was laid from the D6 power supply building to D6V2. After that, a single optical fiber is connected and extended upstream and downstream.
- ◆ The cable is input to PMT module and converted to electrical signals.
 - ◆ Capture/save waveform data
 - ◆ Trigger output by event detection (abort trigger)

The time to issue the abort trigger has become several μs faster.
After installing the fiber loss monitor, this abort trigger was mainly the first to fire.

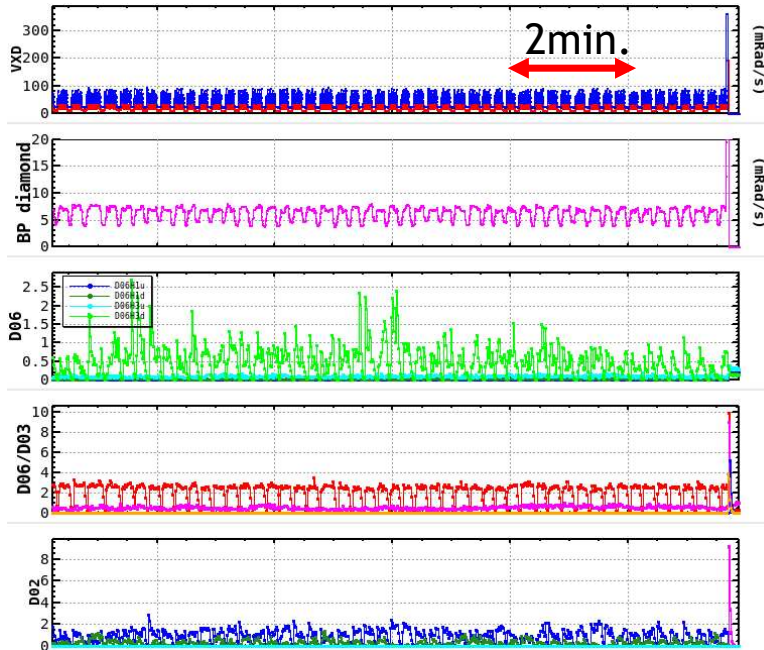
Observations : LM

When we looked at the loss monitor when the abort occurred, which was thought to be caused by beam loss, beam loss looks started within one turn at the whole ring collimator part and Belle-II detector.

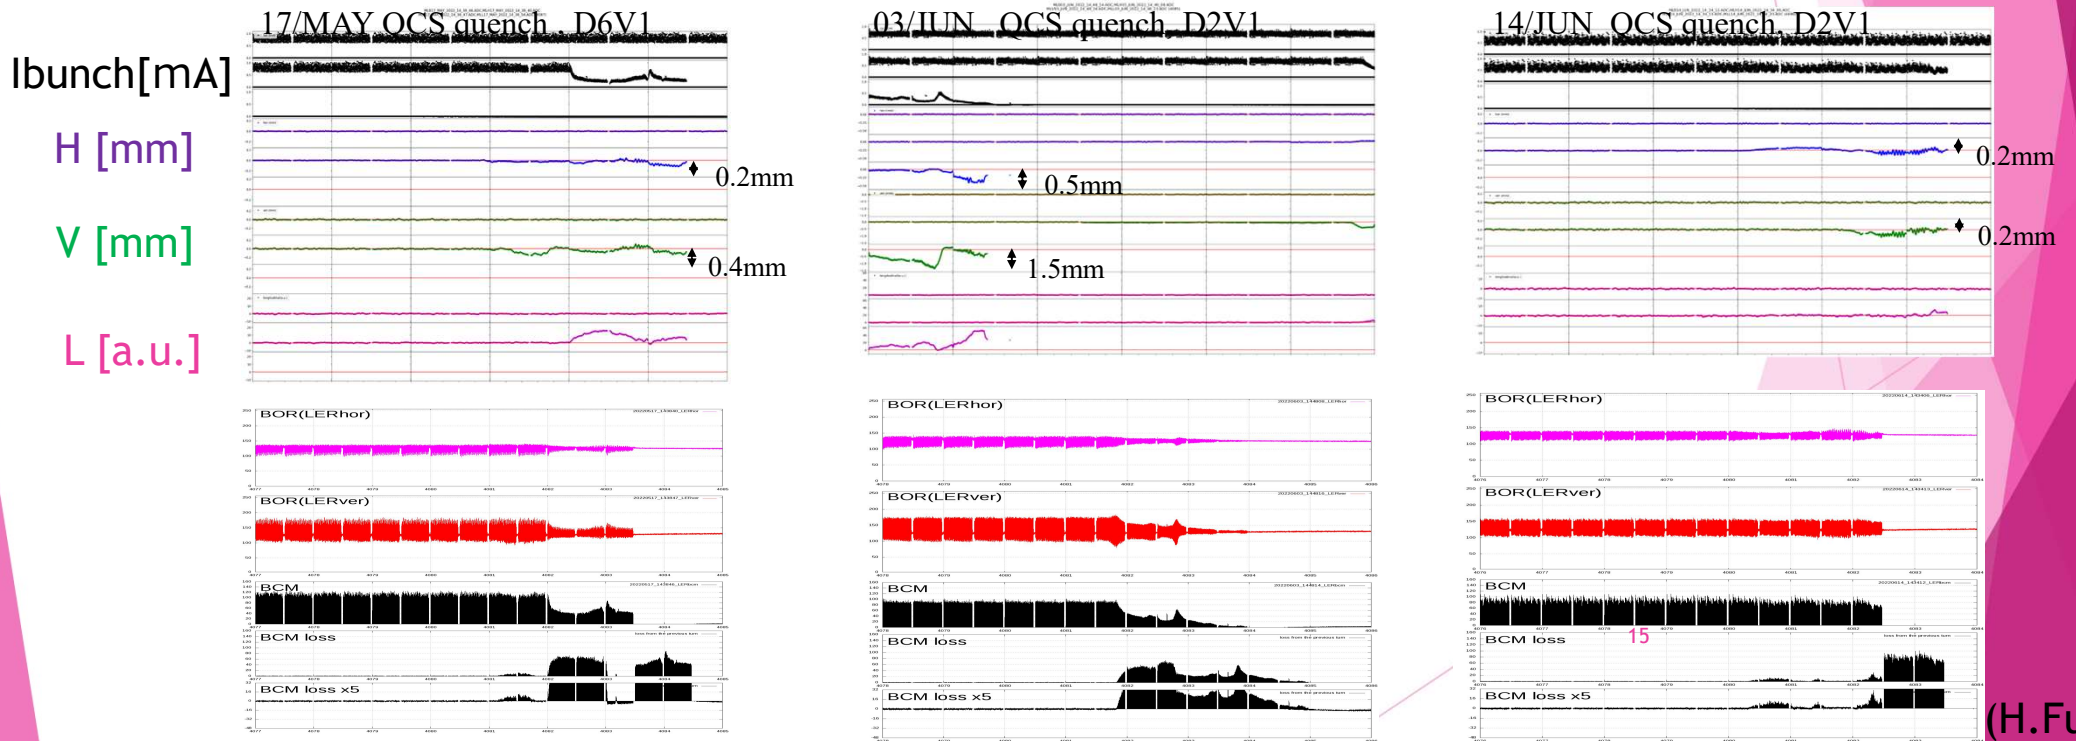
Observations : Bunch Oscillation Recorder (BOR)

- ▶ The Bunch oscillation is measured 4096 turns before the abort trigger using feedback processors and the orbit is calculated from the data.
 - ▶ The orbit changed small $\sim 1\text{mm}$ @FB position

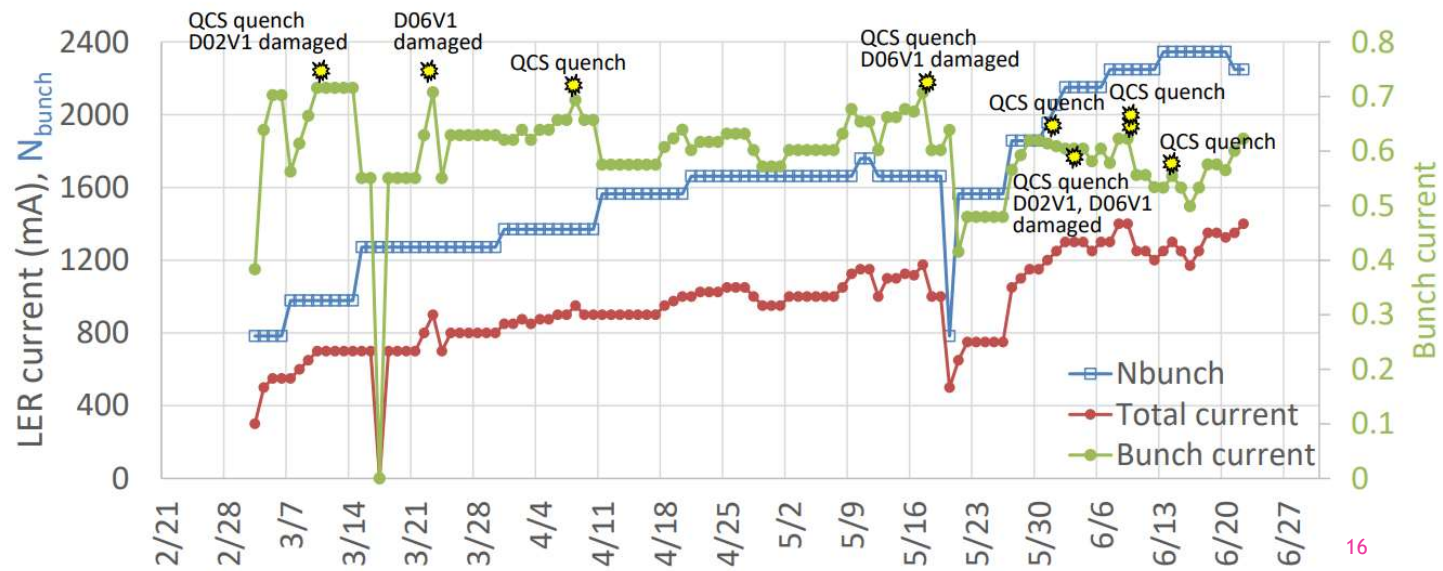
Observations : Bunch Current of Operation

- ▶ It is likely to occur when a **certain bunch current** is exceeded.

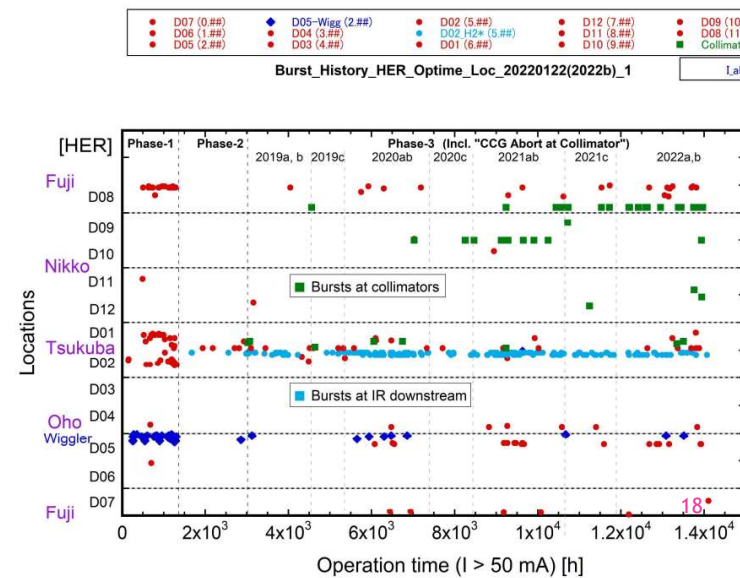
Observations : Vacuum

- ▶ Pressure bursts have been observed here and there, and it rarely occurs in the same place except in the collimator section. It may be the result, not the reason.

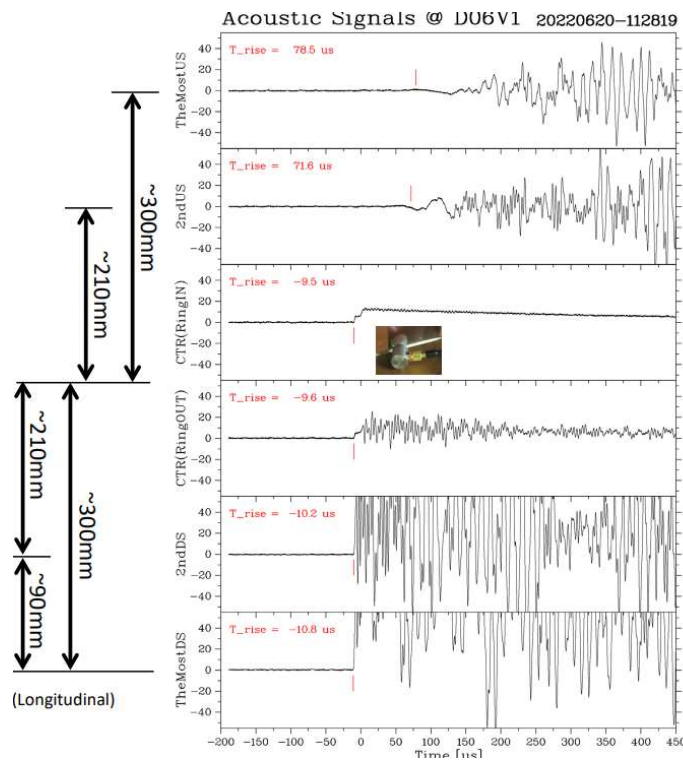
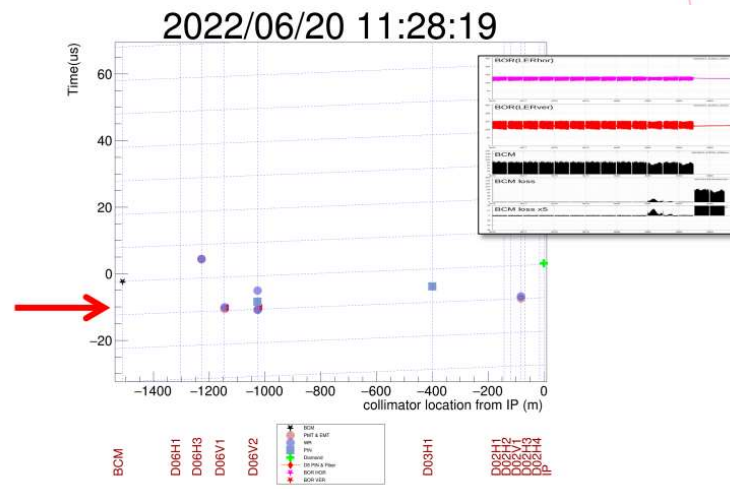
Observations : Acoustic waves

- ▶ **Acoustic waves** were detected at the same time with collimator beam loss.
- ▶ We measure a few event before shutdown

Velocity of acoustic longitudinal (transversal) wave in copper: 4.65 (2.26) mm/us

This data suggests that the particle shower produced at the collimator head generated widespread acoustic wave in the downstream of the head, which propagated upstream.

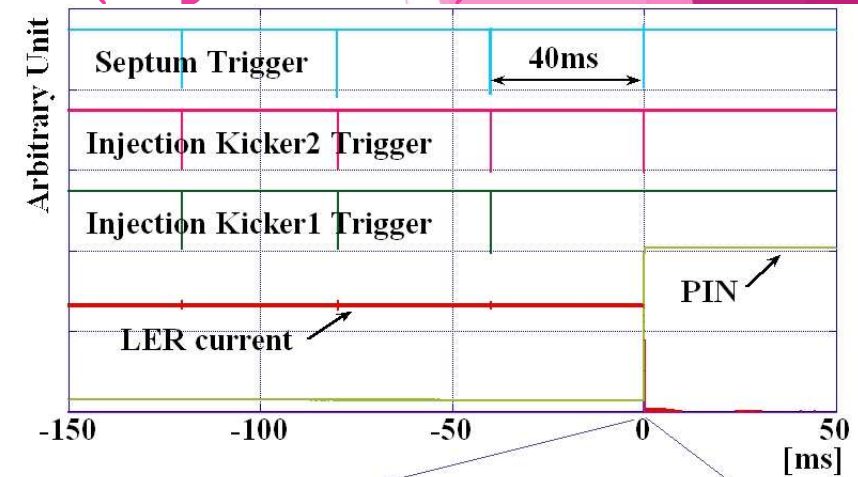
Data Analysis : Loss Monitor Abort (Injection)

LM aborts happened at the end or start of injection.

The upstream injection kicker did not receive the final injection trigger.

The stored beam was kicked only by the downstream kicker ⇒ the beam was lost at that time.

This problem was caused by injection trigger system software, and was fixed after understanding the reason.
