SuperKEKB Shutdown Activities and Operational Plan for 2025c Run

B2GM

June 16, 2025

on behalf of SuperKEKB Commissioning Group

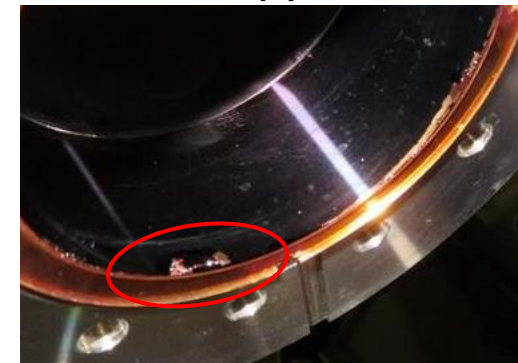
LER D02 beam pipe

- The black stains caused by VACSEAL cannot be removed ethanol-soaked wipes alone.
 - Some black stains have a flaky structure and tend to detach easily.
- The inside surfaces are polished with Scotch-Brite, then cleaned with ethanol-soaked wipes.
 - Beam pipes in the Q-magnets are coated with TiN, and part of this coating is also removed during polishing.
- This cleaning process is also applied to areas without visible black stains, since VACSEAL residues may be present in less visible forms.
- Powdery dust is found throughout the beam pipes, regardless of the presence of black stains. It is removed from accessible areas via the removed bellows chamber openings.
- All flanges are labeled, and work records including photos are documented.

- VACSEAL was used on all flanges in the IR during construction.
- We removed the VACSEAL from all MO-flanges and reinstalled them without using it.
 - LER: 23 MO-flange connections (11 bellows chambers + 1 flange connection)
 - HER: 18 MO-flange connections (9 bellows chambers)
- The connections near the IP cannot be opened during this shutdown.
 - LER: 8 HELICOFLEX-flange connections remain uncleaned (2 bellows chambers on each side closest to the IP)
 - HER: 8 HELICOFLEX-flange connections remain uncleaned (2 bellows chambers on each side closest to the IP)
- No evidence of VACSEAL intrusion into the beam channel (e.g., black stains) has been observed so far with HELICOFLEX flanges.
 - Experimental results have also confirmed that at a leak rate on the order of 1×10^{-9} Pa·m³/s, VACSEAL does not intrude into the beam channel.

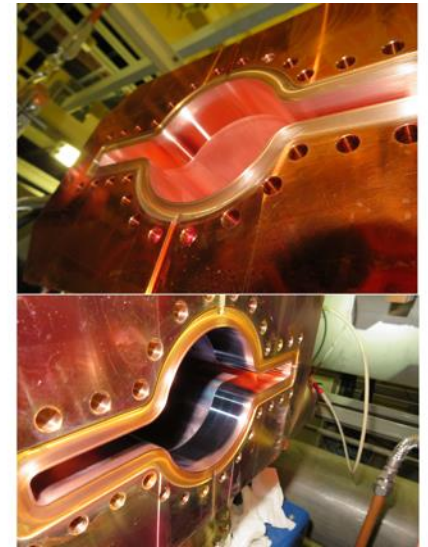
After cleaning

- We removed and inspected all of the bellows chambers in the Oho wiggler section.
 - 52 MO-flange connections (26 bellows chambers)
- Some bellows chambers and beam pipes showed black stains.
- We removed them and reinstalled the chambers without using VACSEAL.

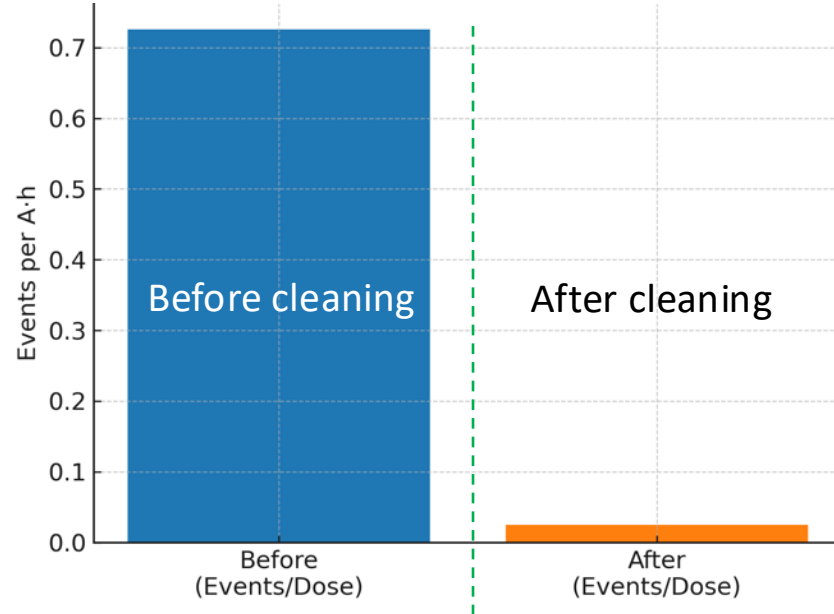
Frequency of **pressure burst per 1 Ah** at CCG D10_L02

- A bellows chamber near CCG D10_L02 was replaced, and VACSEAL was removed from the adjacent beam pipes on Nov. 6 during the 2024c run, using the same cleaning method.
- After this work, the number of pressure bursts in the area has been significantly reduced.

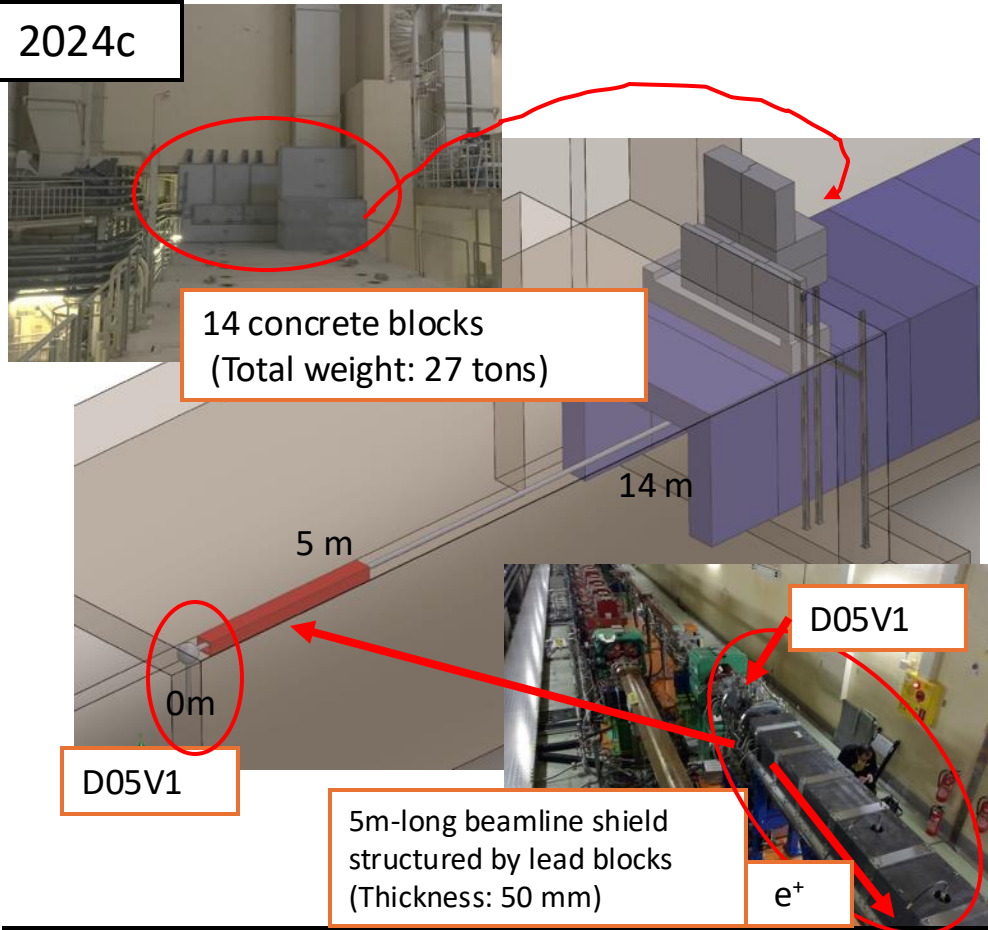
2024c

* Radiation shields were installed at two locations.

- A beamline shield covering ~5 m from D05V1
- A concrete shield added onto the existing shield for the straight section

-> The dose limit within the radiation control area was reached, making additional shielding necessary.

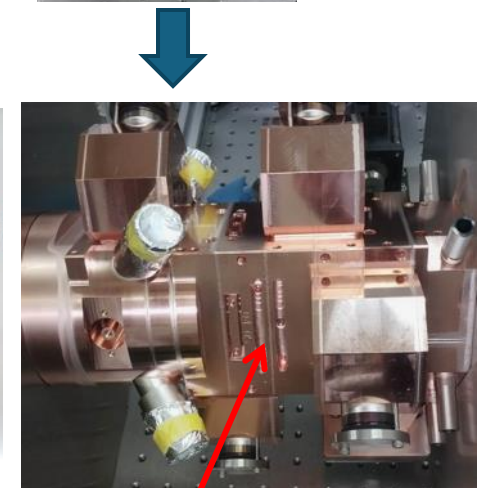
Brazing assembly

- The current RF gun cathode cell includes a choke structure for thermal cleaning of the cathode.
- The updated cathode cell is designed with:
 - Optimized surface field
 - Additional vacuum pumping
 - A new triplet downstream of the gun
- During brazing, the wrong cavity cell was assembled, resulting in a 10 MHz frequency offset (No tuning required for cathode side cavity chain).
- Tuning of the RF cavity is scheduled this week. RF conditioning will be performed until July.

- If tuning cannot sufficiently correct the frequency offset and the schedule is delayed, a new IrCe cathode plug will be installed in the current RF gun.
