Injector Linac Status

Feb. 22nd, 2020
Masanori Satoh (KEK, Acc. Lab.)
for Injector Linac Group

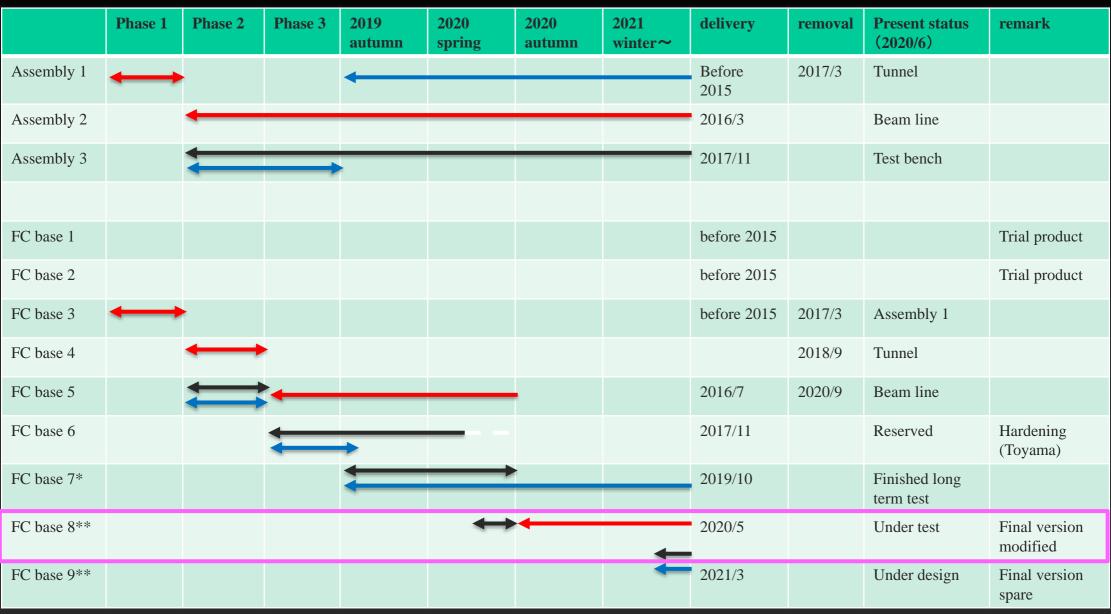
FC assembly, base summary

- *Base 7, 8, 9 (head : $Cu \rightarrow NC50$, return yoke : $SS400 \rightarrow permendur$)
- **Base 8, 9 Shape optimization (insulation, leakage magnetic field)

red: operation

blue: spare

black: test bench

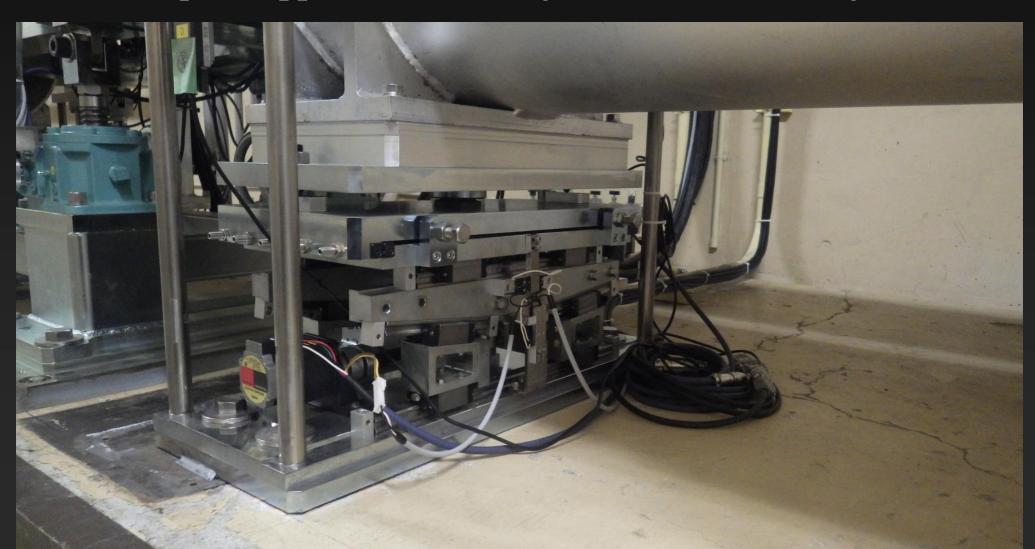
Movable girder for accelerating structure

- Six movable girders have been installed in Sector3 (in summer shutdown of 2019).
 - Four 2-m-long accelerating structures are mounted on one girder.
- It could help to suppress emittance growth due to misalignment.
